CLIENT:		SITE PLAN	
			CITY OF RED DEER SLOPE STABILITY EVALUATION EAST RED DEER RIVER BANK (OPPOSITE 3 MILE BEND)	
	DRAWN:	CHK'D:	REV #:	DATE:
	PS	MDB	2	APRIL 2019
SCALE:		JOB NO.		DRAWING NO.
1:7500		RD6500-9/10		FIGURE 9/10-1

**CITY OF RED DEER
SLOPE MONITORING PROGRAM
2018 INSPECTION REPORT**

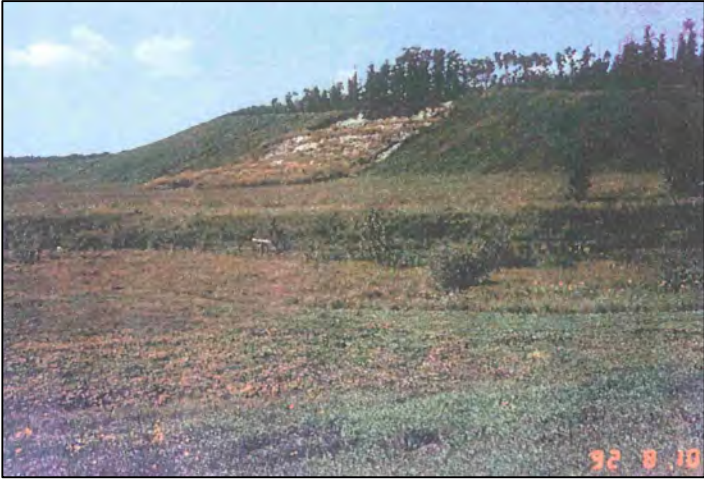
PHOTO 5 (2018): SLOPE AND SLOUGH AREA AT THE TOE, TAKEN FROM RAILWAY TRACKS, FACING NORTH

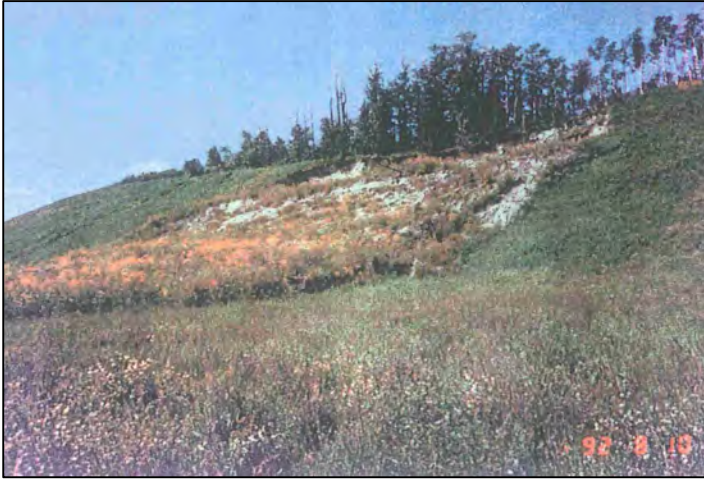
PHOTO 18 (1992): CUT SLOPE AREA AND SLOPE FAILURE, FACING SOUTHWEST (HBT AGRA)

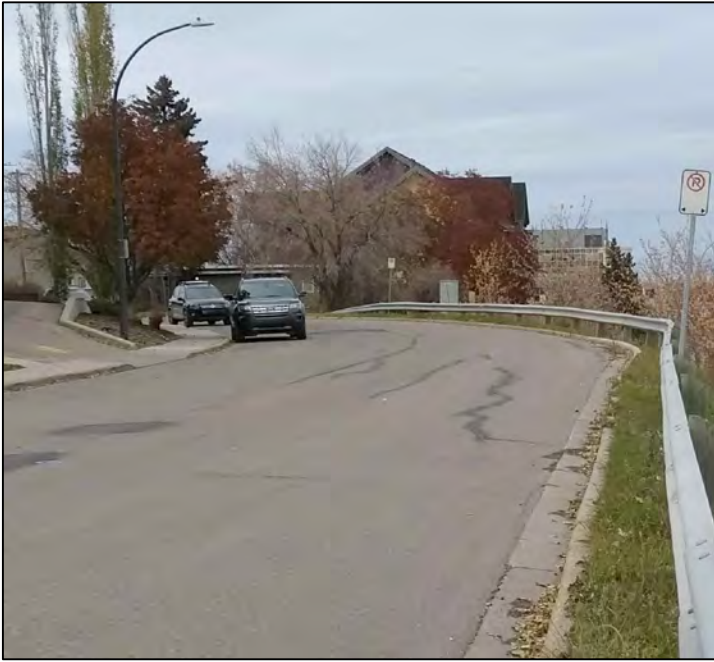
PHOTOGRAPH 7 (2018): SEALED CRACKS AND ROTATED GUARD RAIL ON SERVICE ROAD AT THE CREST OF SLOPE, FACING NORTH

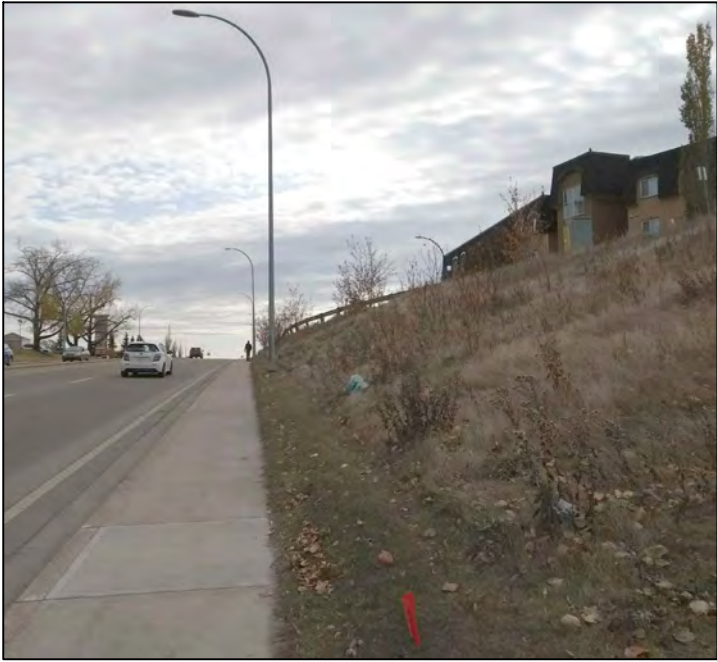
PHOTOGRAPH 11 (2018): TOE OF THE SLOPE, TAKEN FROM SIDEWALK ON WEST SIDE OF GAETZ AVE, FACING SOUTH

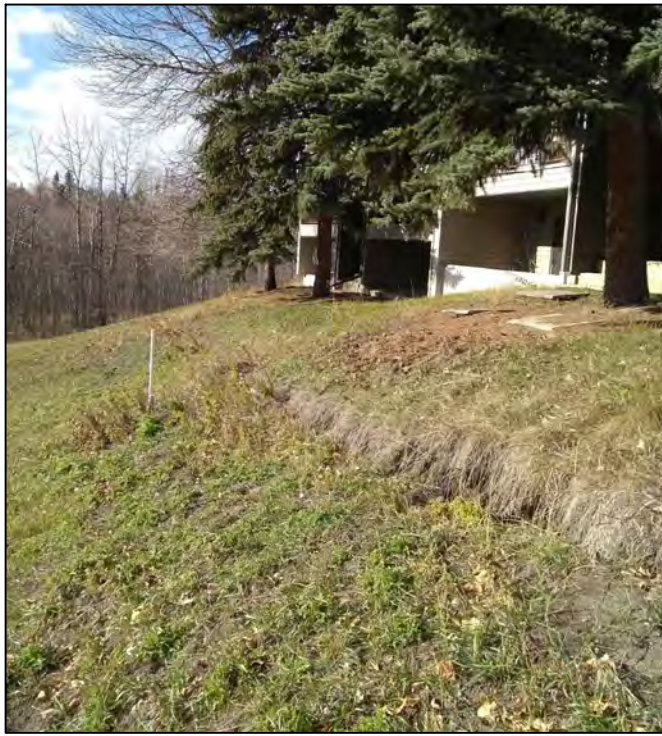
PHOTOGRAPH 16 (2018): TENSION CRACKS ALONG CREST OF 1982 LANDSLIDE SLOPE, FACING NORTHWEST

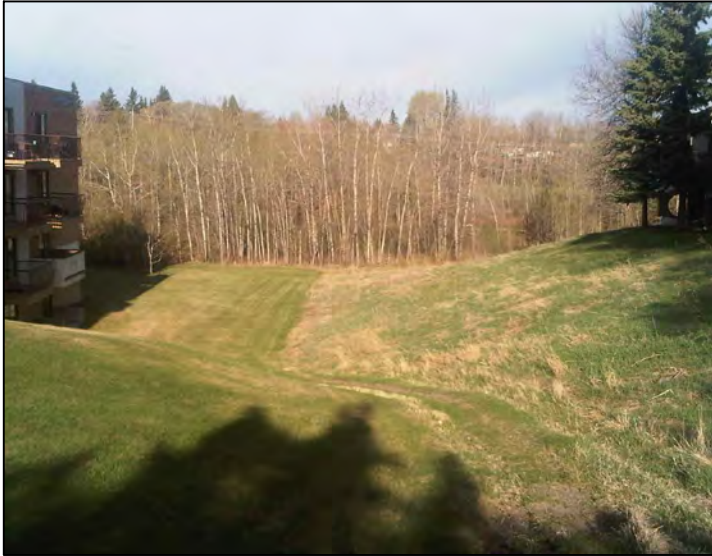
PHOTOGRAPH 18 (2012): 1982 LANDSLIDE SLOPE AREA BETWEEN APARTMENTS, FACING WEST

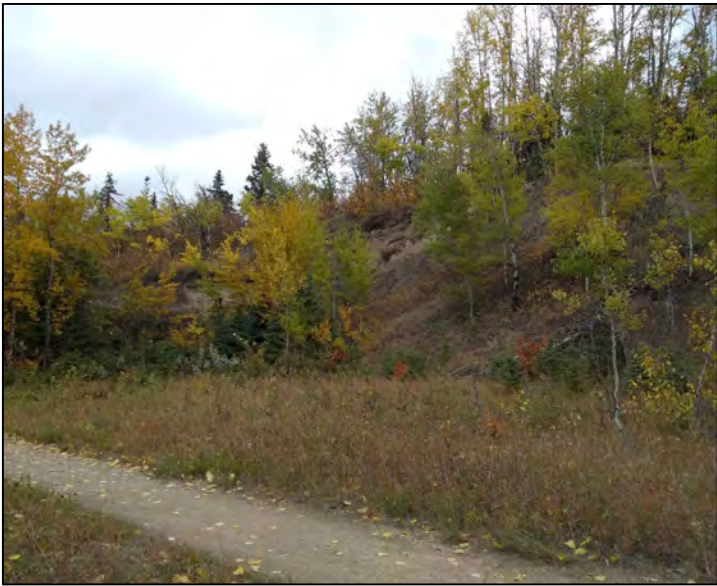
PHOTOGRAPH 6 (2018): SLOPE ABOVE THE MINOR SLIDE , TAKEN FROM CREST OF FAILURE, FACING NORTH

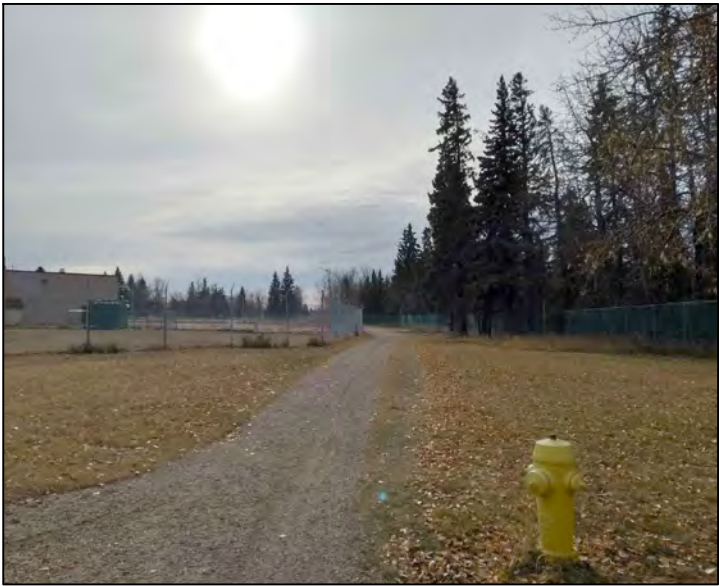
PHOTOGRAPH 15 (2018): TRAIL ALONG THE CREST, FACING SOUTH

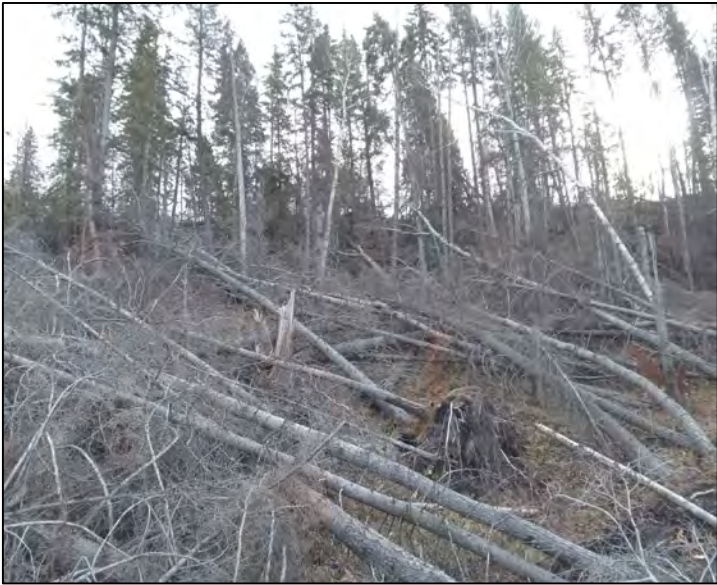
PHOTOGRAPH 28 (2018): FALLEN TREES DUE TO 2017 WINDSTORM, TAKEN FROM CREST OF FAILURE, FACING SOUTHEAST

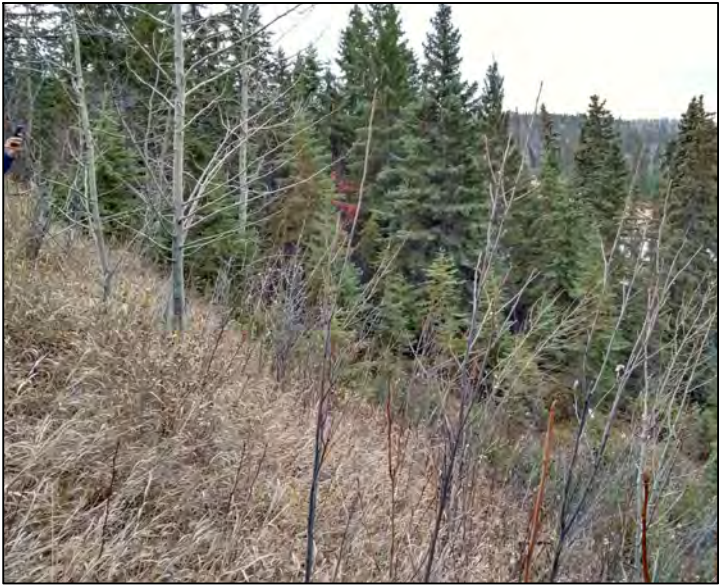
PHOTOGRAPH 55 (2018): SLOPE AT THE MINOR SLIDE, FACING SOUTH
