To: Tracy Seppala, Waste Management Technical Specialist
Janet Whitesell, P. Eng., Waste Management
Superintendent

File: 704-SWM.SWOP04071-03.002

Subject: River Side Heavy Dry Waste Site 2022 Site Walkover

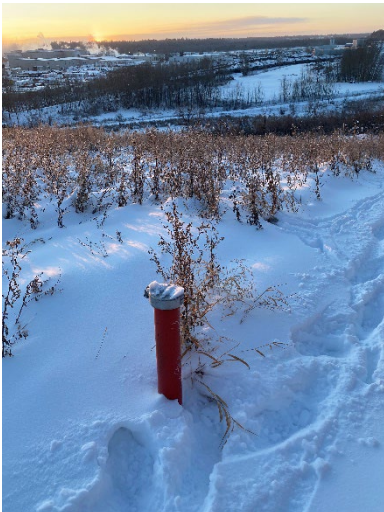
Photo 1: Monitoring Well MW-01

The Site Walkover at the Site was conducted on November 8, 2022. The Site was walked over by field staff, all monitoring wells were assessed, the wells were locked and determined to be in good condition. The Site was unchanged in 2022 from 2021, and the Site had no noticeable damage to the cover or exposed waste. At the time of the site visit, the Site was snow covered. Pictures of the monitoring wells and the Site are included below.

- All groundwater and the vapour well were in good condition, the Site was unchanged from 2021 and there was no noticeable damage to the cover or exposed waste. However, future site walkovers should be conducted in the summer or early fall prior to snowfall to fully assess the cover.
