**Date:** April 11, 2023

**File:** 704-SWM.SWOP04071-03.001

**Subject:** Great West Adventure Park 2022 Site Walkover

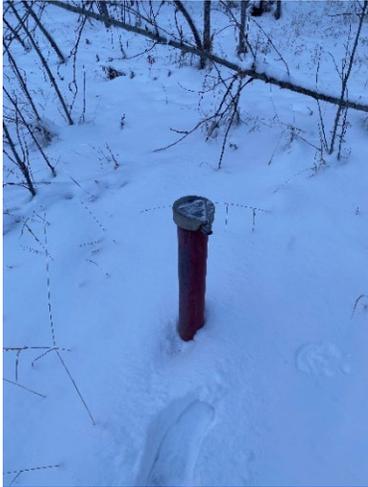
**Photo 1: Monitoring Well MW-01**

The Site Walkover at the Site was conducted on November 6, 2022 and December 9, 2022. On November 6, the Site was walked over by field staff, all stickup monitoring wells were assessed and were locked and determined to be in good condition. The flush mount wells (MW-02 and VW-03) could not be located on November 6 and field staff returned on December 9 and located the flush mount wells and they were determined to be in good condition. The Site was unchanged in 2022 from 2021, and the Site had no noticeable damage to the cover or exposed waste. Both on November 6 and December 9, the Site was snow covered. Pictures of most of the monitoring wells and the Site are included below. It was noted that MW-05 was missing a lid on the casing; however, the well is locked with a locking j-plug and lock.
