CLIENT:		SITE PLAN	
			CITY OF RED DEER SLOPE STABILITY EVALUATION EAST RED DEER RIVER BANK (OPPOSITE 3 MILE BEND)	
	DRAWN:	CHK'D:	REV #:	DATE:
	PS	MDB	2	APRIL 2019
SCALE:		JOB NO.		DRAWING NO.
1:7500		RD6500-9/10		FIGURE 9/10-1

**CITY OF RED DEER
SLOPE MONITORING PROGRAM
2018 INSPECTION REPORT**

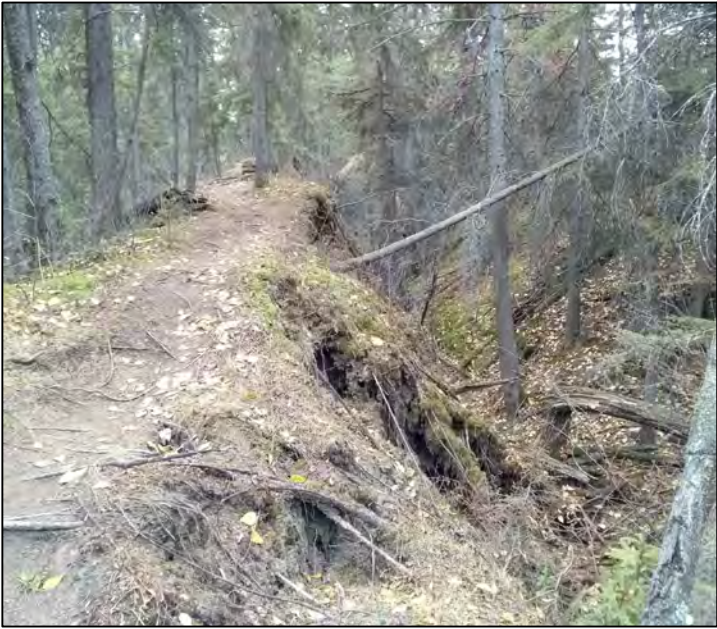
PHOTOGRAPH 59 (2018): MID-SLOPE RIDGE NEAR POND (FORMED DUE TO THE MOVEMENT OF SLOPE OVER THE YEARS), FACING SOUTHWEST

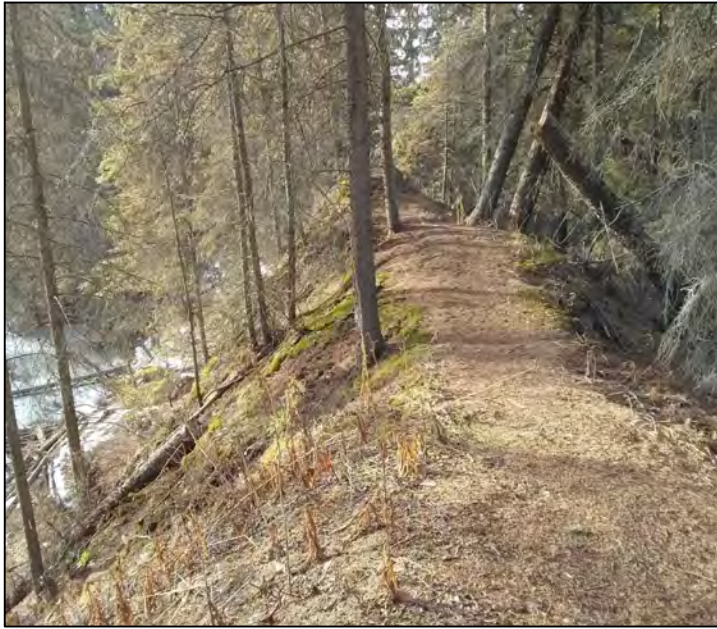
PHOTOGRAPH 72 (2018): NORTH RIDGE AND SLOPE ADJACENT TO POND, FACING SOUTHWEST

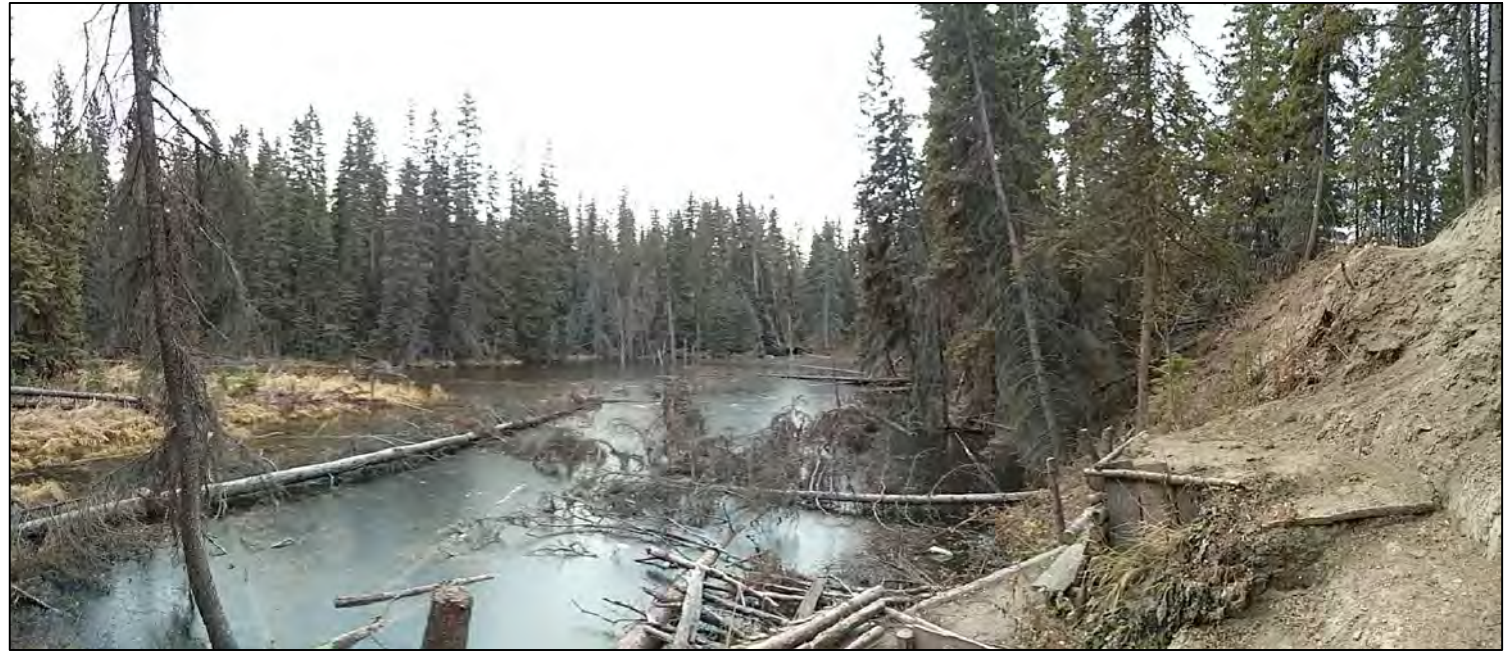
PHOTOGRAPH 68 (2018): POND, PHOTO TAKEN FROM NORTHWEST CORNER, FACING SOUTH

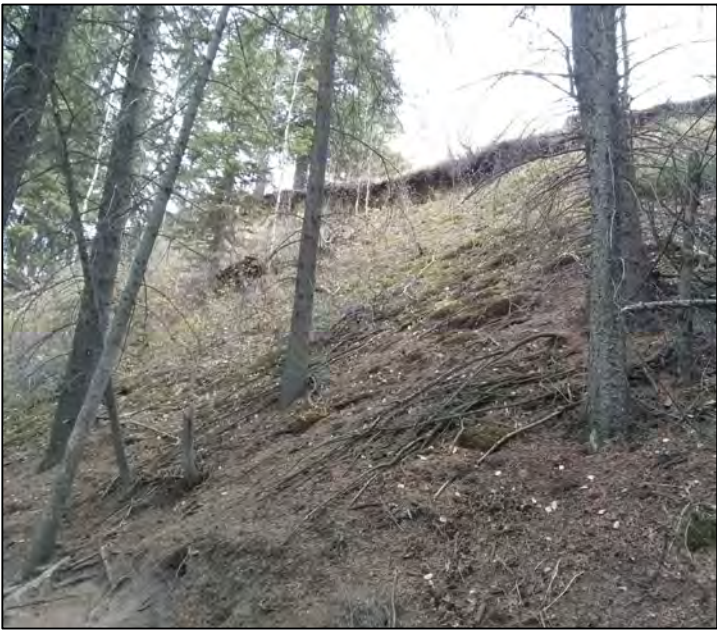
PHOTOGRAPH 104 (2018): SLOPE FACE AT AN OVER-STEEPENED AREA, LOOKING UP THE SLOPE, FACING EAST

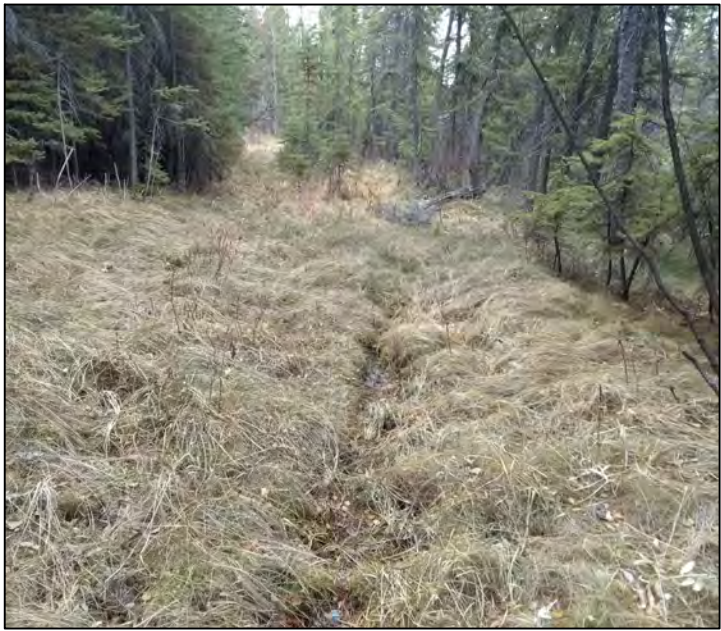
PHOTOGRAPH 180 (2018): RIDGE WITH STANDING WATER, LOOKING ALONG THE RIDGE, FACING SOUTH

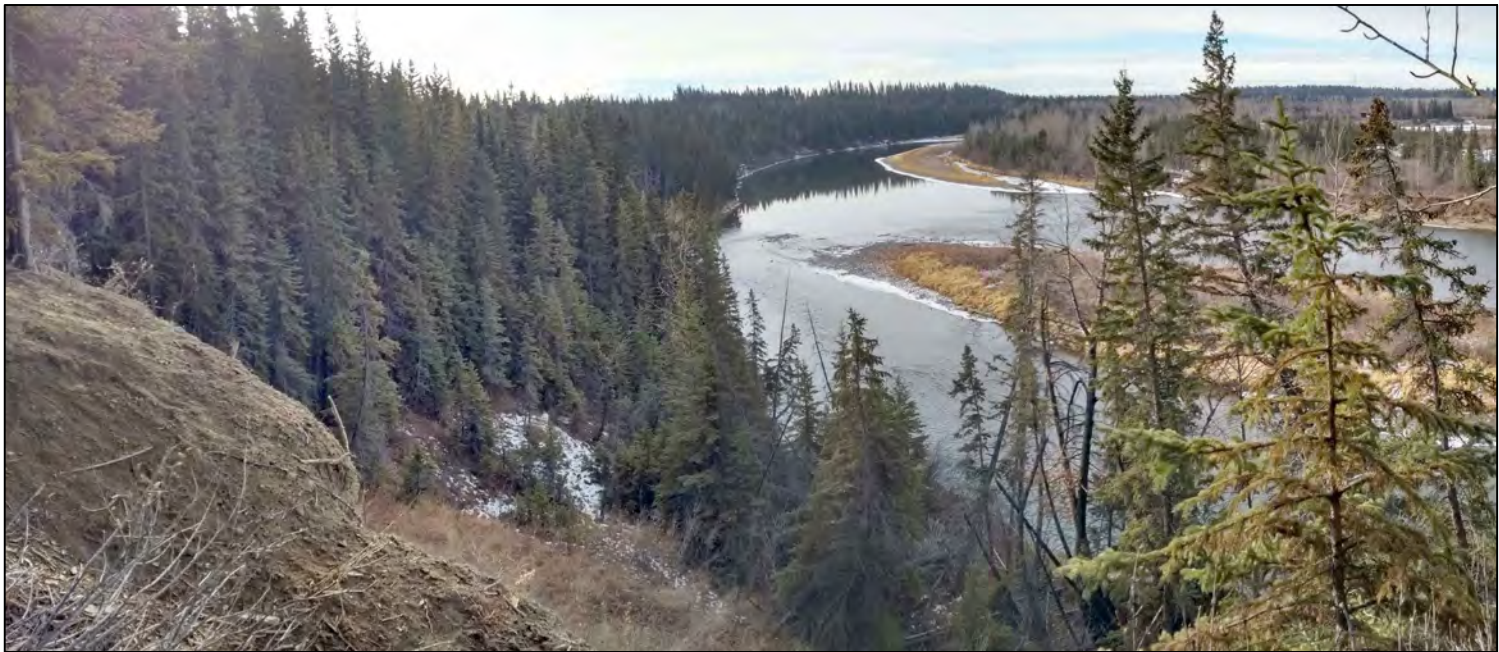
PHOTOGRAPH 253 (2018): SLOPE ALONG THE RIVER, FACING SOUTHWEST

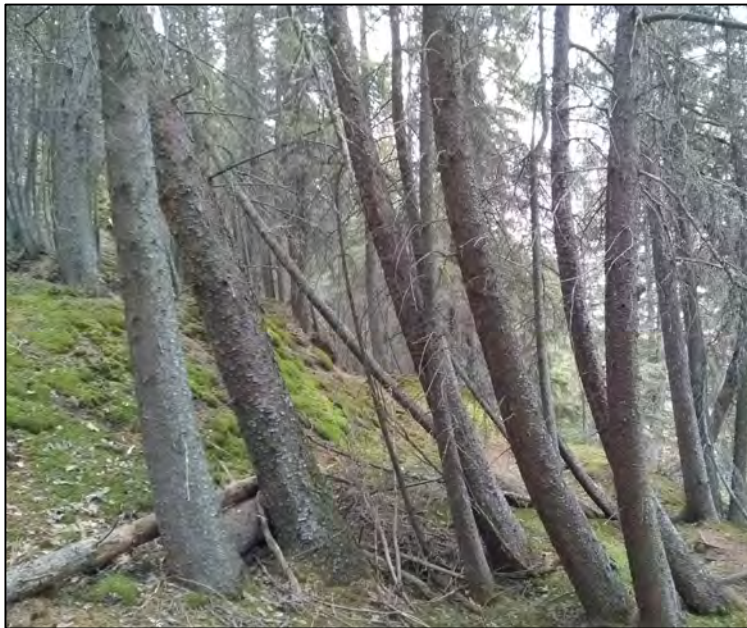
PHOTOGRAPH 271 (2018): NON-VERTICAL TREES ACROSS THE SLOPE, FACING WEST

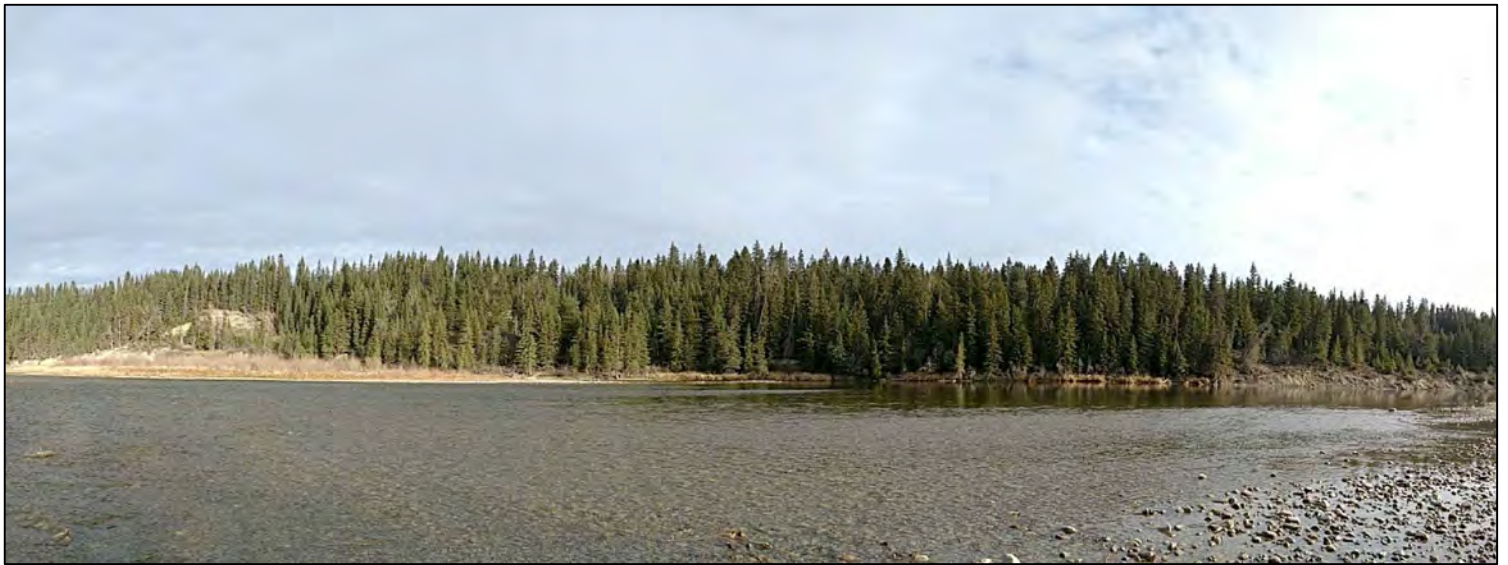
PHOTOGRAPH 277 (2018): EAST RIVER BANK, TAKEN FROM THREE MILE BEND, FACING EAST

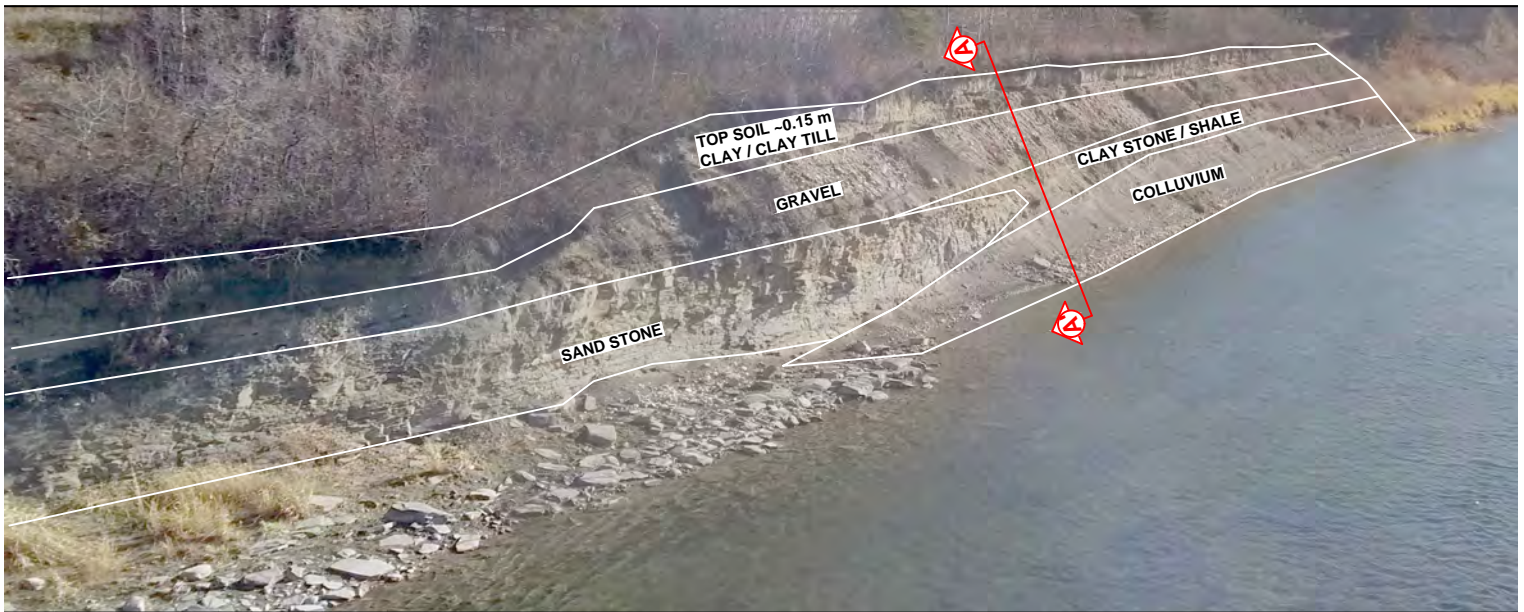
The existing crest area and steeper sections of the slope face along this exposed river bank are considered to be stable in the short-term and marginally stable in the long-term. The apparent stability levels for these steep faces are attributed to the presence of dense gravel and shallow bedrock within the bank profile. Rotational landslides have not occurred in river bank in this area, but minor spalling probably occurs on an infrequent basis after flood events. The potential for a landslide and significant loss of upland area above this site is very low. A preliminary set back to provide a buffer for permanent development is considered to be 8 m from the crest or on a line extended up at 2.3H:1V from the shore of the river bank.

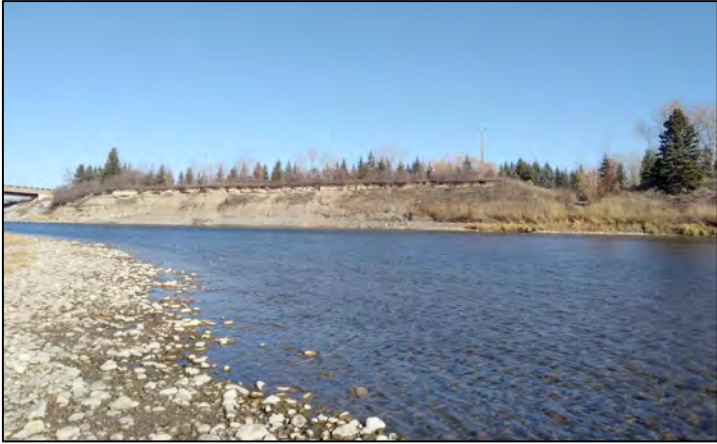
PHOTOGRAPH 4 (2018): EAST RIVER BANK FROM RIVER ACCESS ON THE WEST SIDE OF RIVER, FACING NORTH

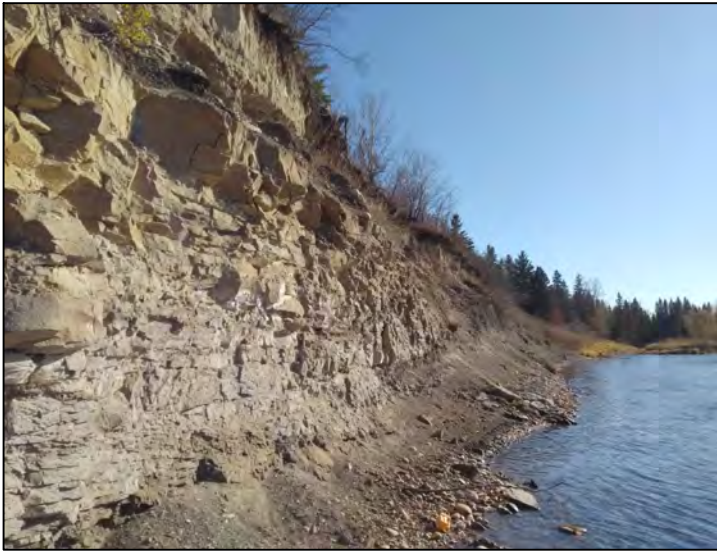
PHOTOGRAPH 8 (2018): VERTICAL SANDSTONE ESCARPMENT OF EAST RIVER BANK AT THE NORTH END OF STUDY AREA, FACING SOUTHEAST

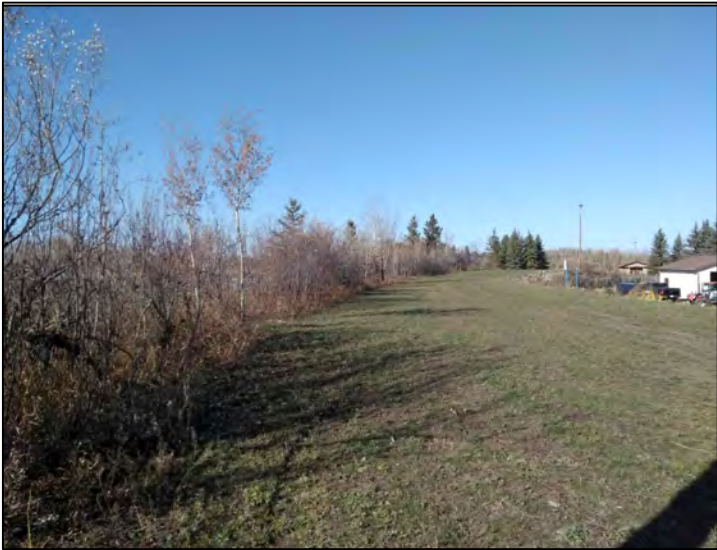
PHOTOGRAPH 18 (2018): CROSS COUNTRY SKI TRAIL BETWEEN CREST OF SLOPE AND GOLF COURSE MAINTENANCE YARD AT NORTH END OF STUDY AREA, FACING NORTHWEST

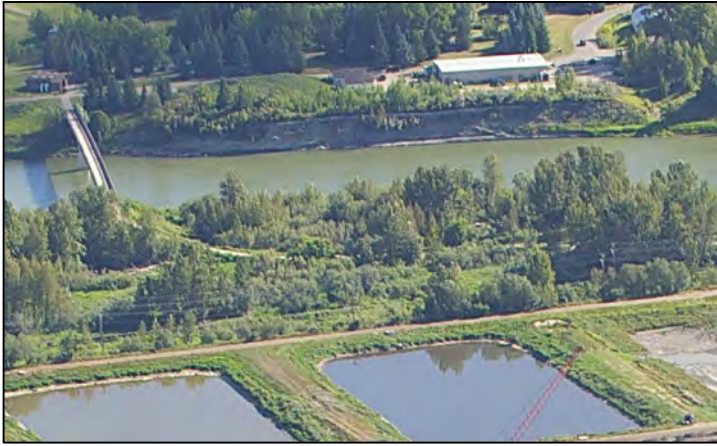
PHOTOGRAPH 37 (2014): EAST RIVER BANK FROM AERIAL PHOTOGRAPH OVER 78A STREET CLOSE, FACING NORTHEAST

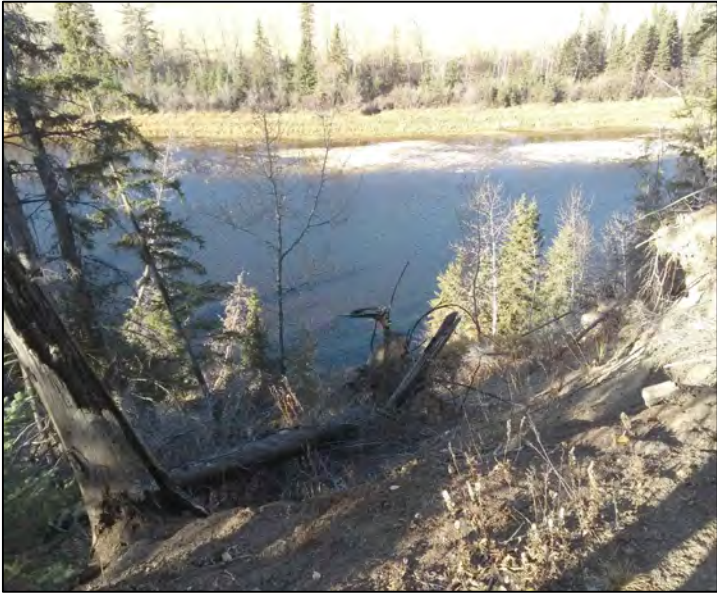
PHOTOGRAPH 14 (2018): OLD SLIDE BY THE EAST RIVER BANK (CENTER/SOUTH PROPERTY), FACING WEST

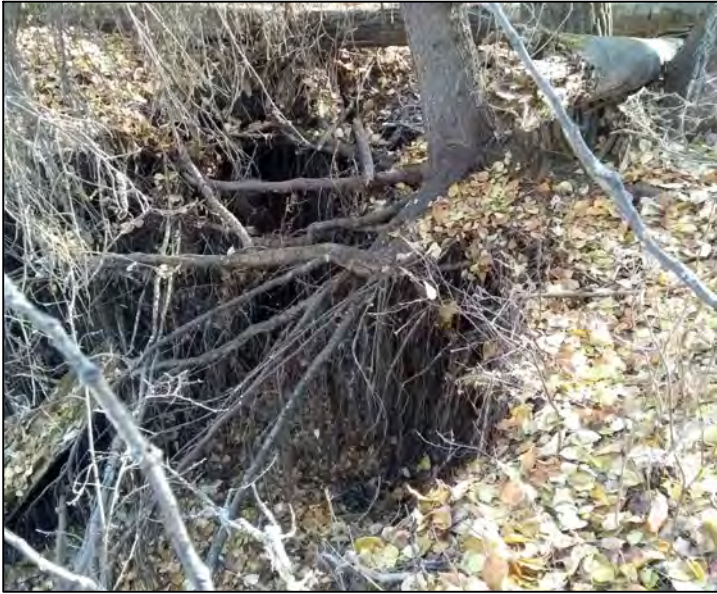
PHOTOGRAPH 20 (2018): DRAINAGE DITCH (SOUTH END), FACING EAST

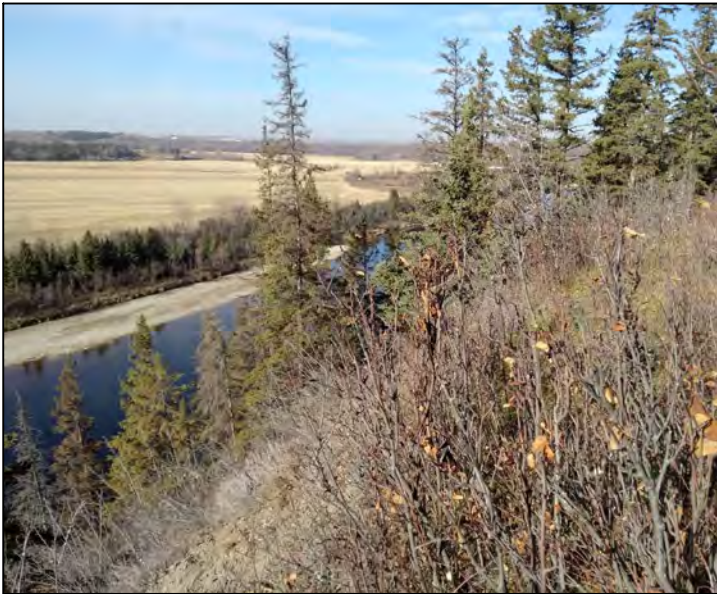
PHOTOGRAPH 40 (2018): STEEP SLOPE BY THE EAST RIVER BANK, FACING NORTHWEST

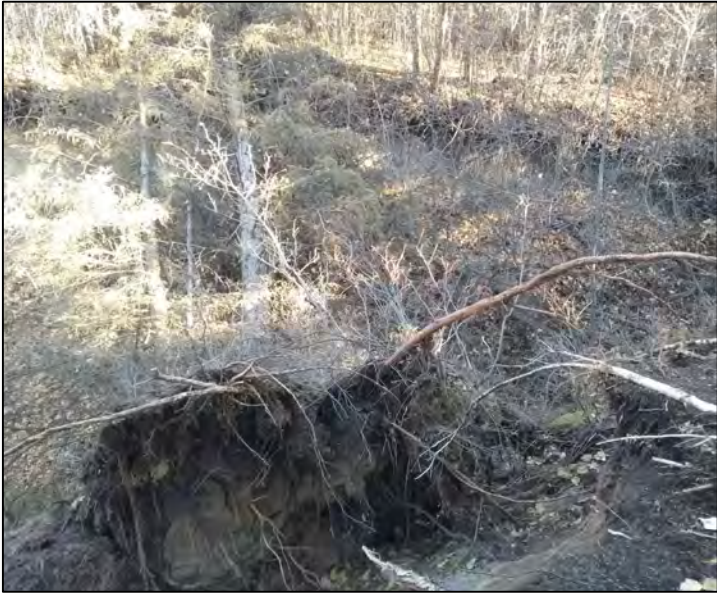
PHOTOGRAPH 41 (2018): SLOPE AND UPROOTED TREE FROM ABOVE THE DRAINAGE DITCH, FACING NORTH

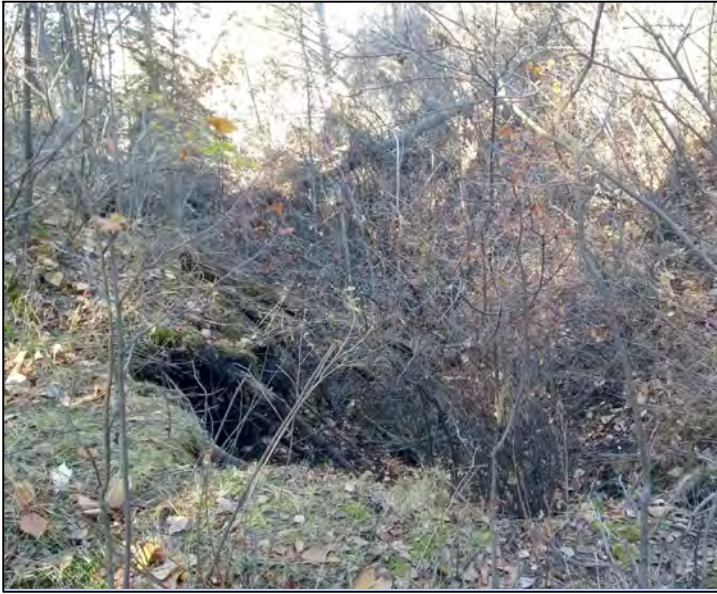
PHOTOGRAPH 43 (2018): DRAINAGE DITCH (NORTH END), FACING NORTHWEST

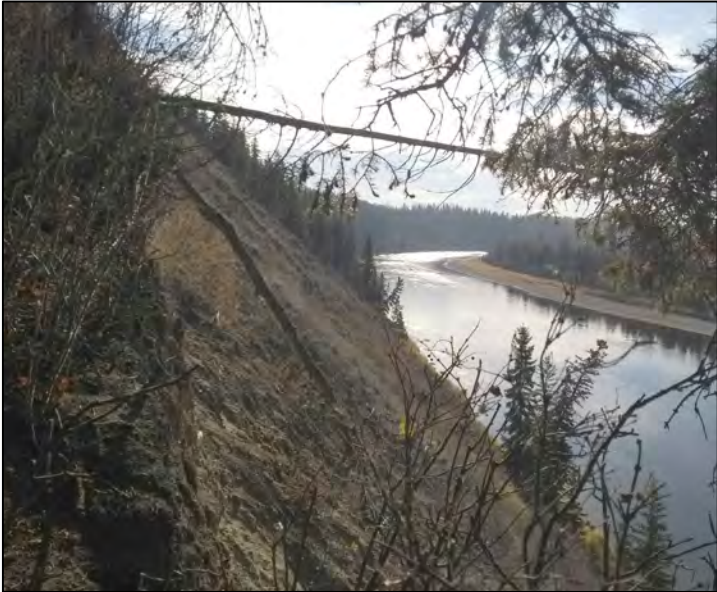
PHOTOGRAPH 49 (2018): SLOPE ALONG THE EAST RIVER BANK, LOOKING SOUTH FROM NORTH END

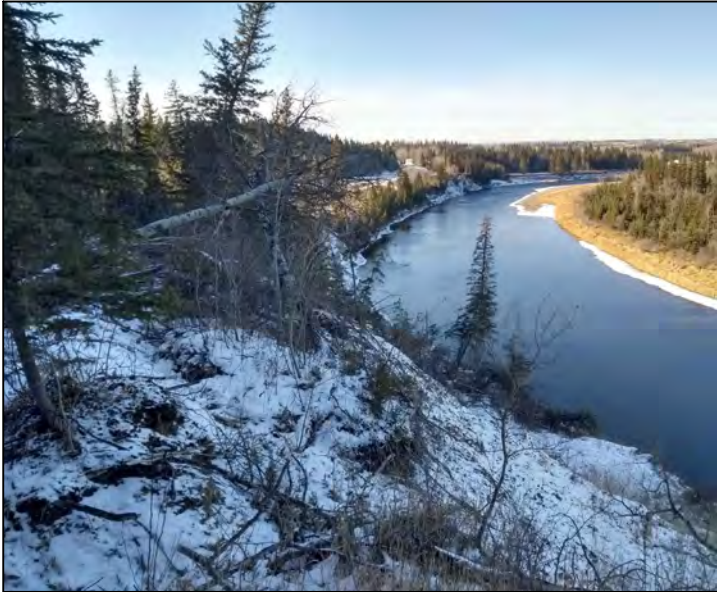
PHOTOGRAPH 65 (2018): OLD SLIDES IN THE SOUTH EXTENT OF STUDY AREA, FACING SOUTHWEST

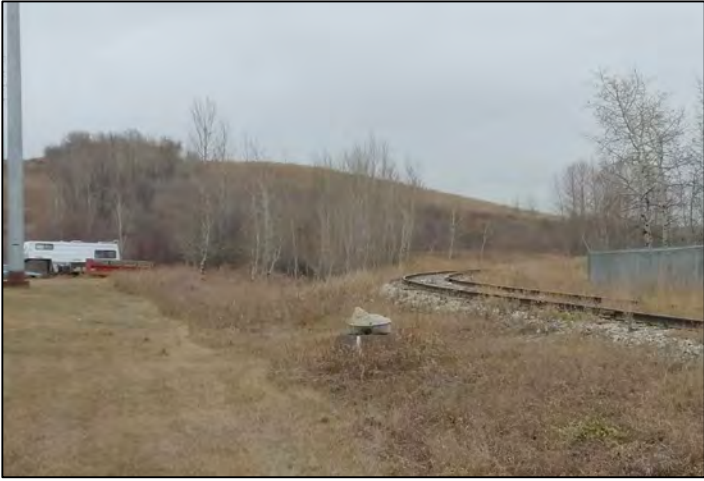
PHOTO 1 (2018): SLOPE AND TRANSMISSION LINE RIGHT OF WAY, TAKEN FROM WEST EDGE OF RAIL TRACKS NEAR 7794 47 AVE CLOSE, FACING NORTH

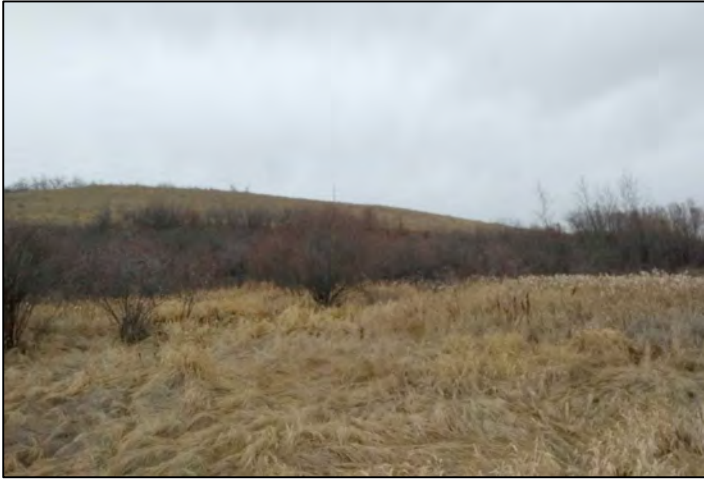
PHOTO 5 (2018): SLOPE AND SLOUGH AREA AT THE TOE, TAKEN FROM RAILWAY TRACKS, FACING NORTH

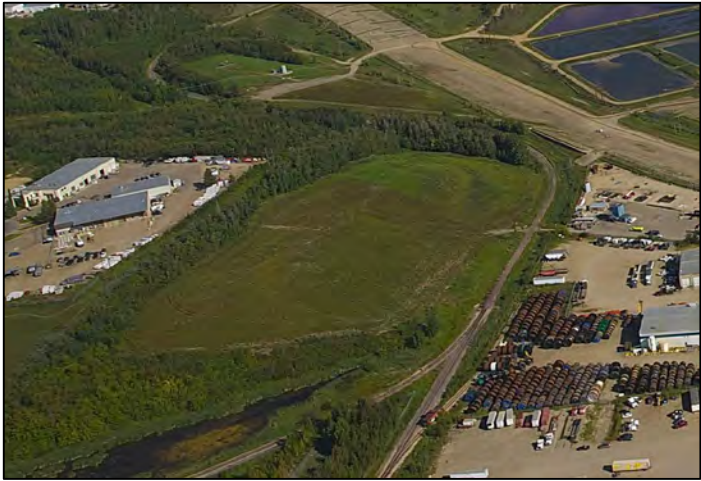
PHOTO 21 (2014): REMEDIATED SLOPE, TAKEN FROM AERIAL LOCATION OVER 77 STREET, FACING NORTHEAST (STANTEC)

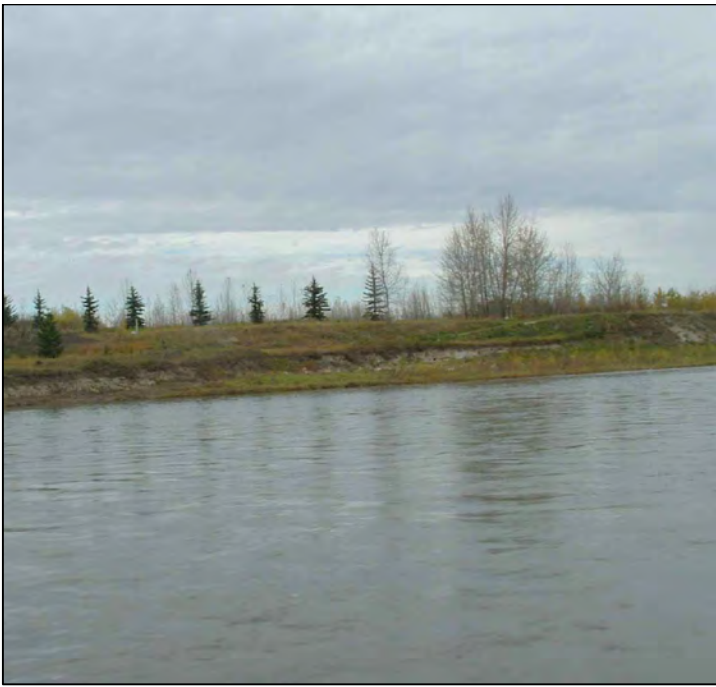
PHOTOGRAPH 2 (2005): NORTH RIVER BANK AT THE ELBOW OF RIVER, NEAR THE WEST END OF STUDY AREA 1, FROM CENTER OF RIVER, FACING NORTH

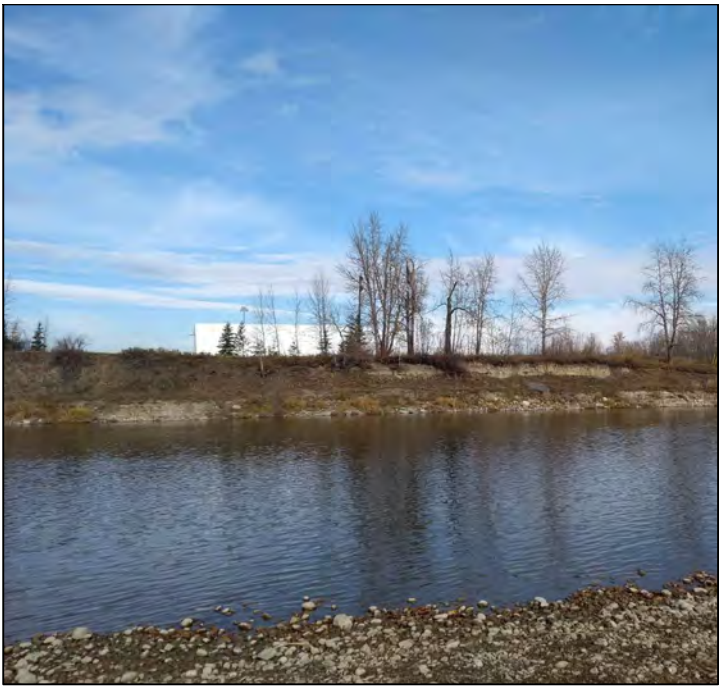
PHOTOGRAPH 2 (2018): NORTH RIVER BANK AT WEST END OF STUDY AREA 1, FROM RIVER ACCESS AT MCKENZIE RECREATION AREA, FACING NORTH

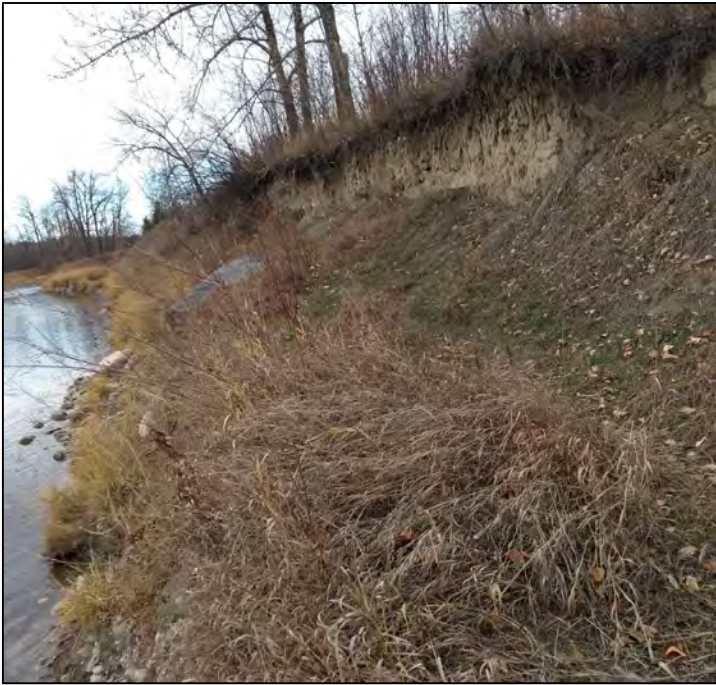
PHOTOGRAPH 8 (2018): NORTH RIVER BANK VERTICAL CUT AND BENCH IN THE CENTER OF STUDY AREA 1, FACING WEST

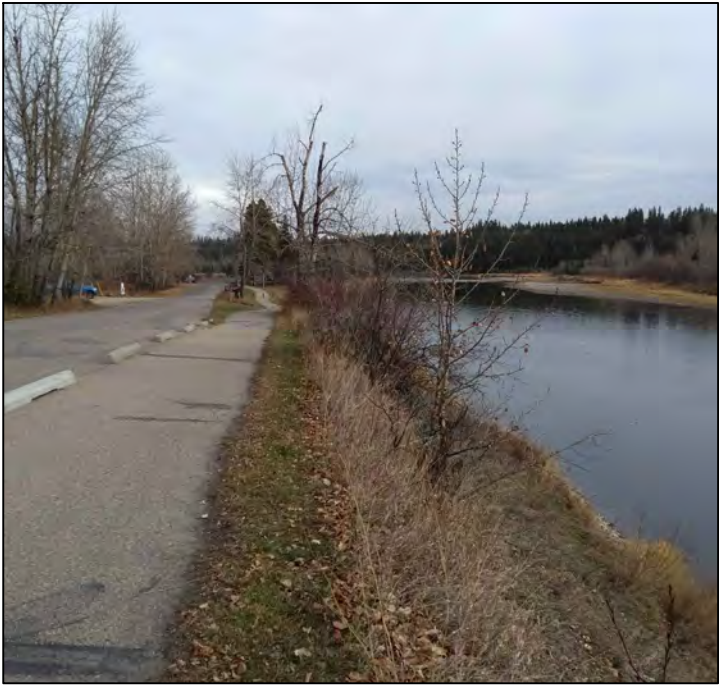
PHOTOGRAPH 21 (2018): NORTH RIVER BANK AT WEST END OF STUDY AREA 1 FROM THE EDGE OF PEDESTRIAN TRAIL, FACING EAST

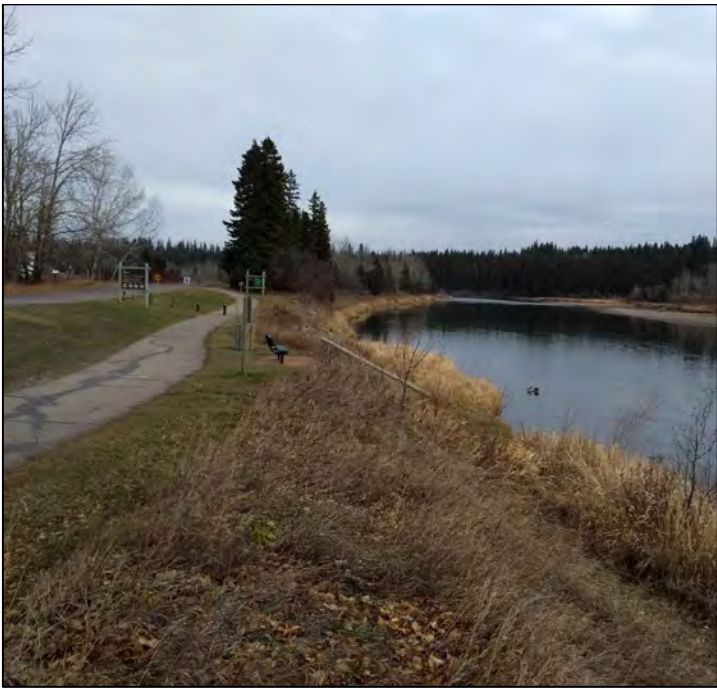
PHOTOGRAPH 28 (2018): NORTH RIVER BANK AT WEST OF STUDY AREA 1 FROM THE EDGE OF PEDESTRIAN TRAIL, FACING EAST

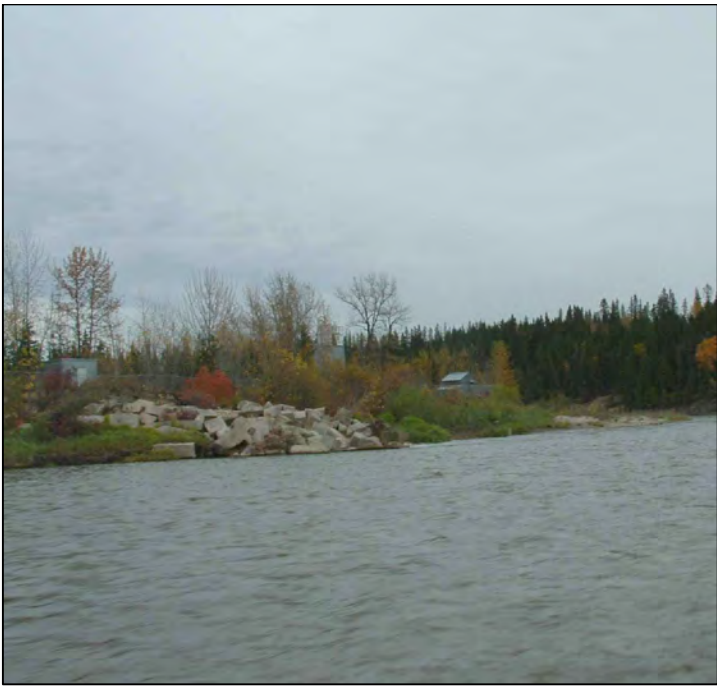
PHOTOGRAPH 31 (2005): NORTH RIVER BANK AND WASTE CONCRETE BLOCKS AT THE EAST END OF STUDY AREA 2, FROM THE CENTER OF RIVER, FACING NORTHEAST

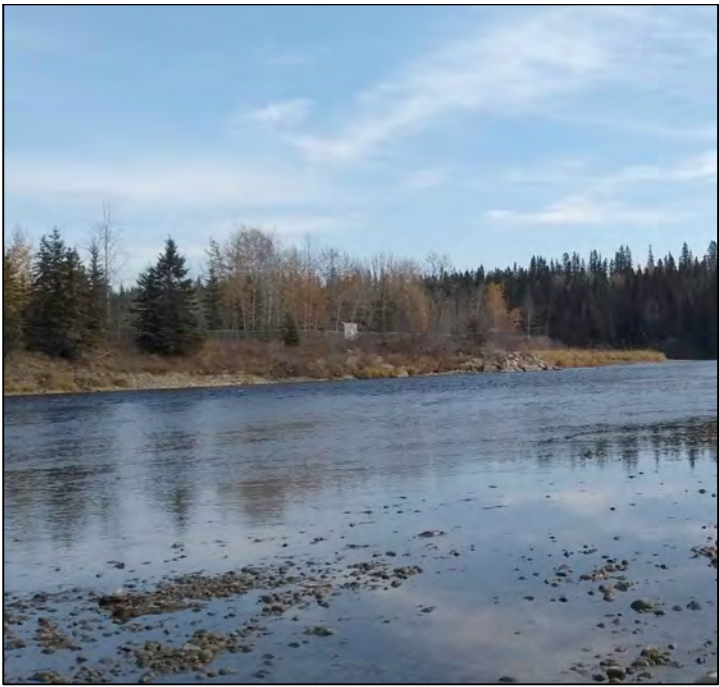
PHOTOGRAPH 31 (2018): NORTH RIVER BANK AND WASTE CONCRETE BLOCKS AT THE EAST END OF STUDY AREA 2, FROM SOUTH SIDE OF RIVER NEAR MCKENZIE RECREATION AREA, FACING NORTHEAST

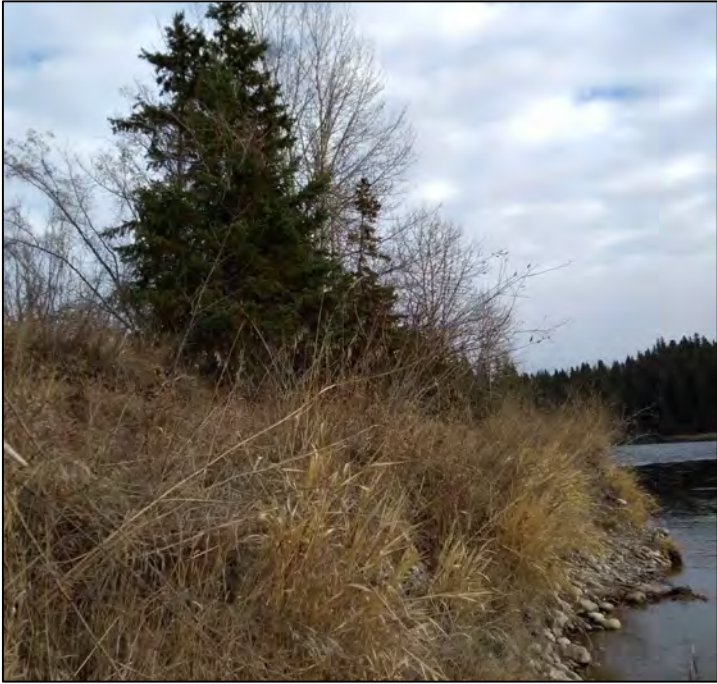
PHOTOGRAPH 45 (2018): NORTH RIVER BANK FROM WEST END OF STUDY AREA 2, FACING EAST ALONG THE RIVER

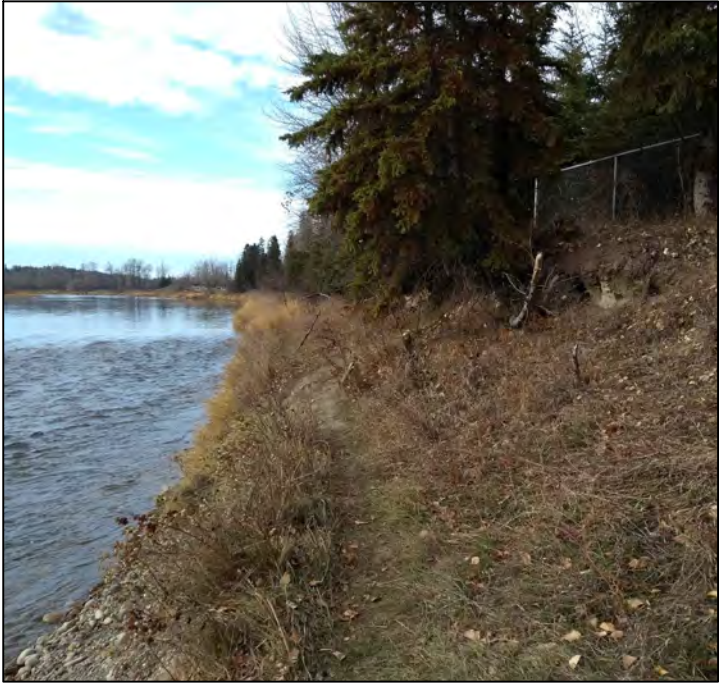
PHOTOGRAPH 66 (2018): NORTH RIVER BANK FROM EAST END OF STUDY AREA 2 NEAR FENCE FOR OIL LEASE, FACING WEST AGAINST THE FLOW OF THE RIVER

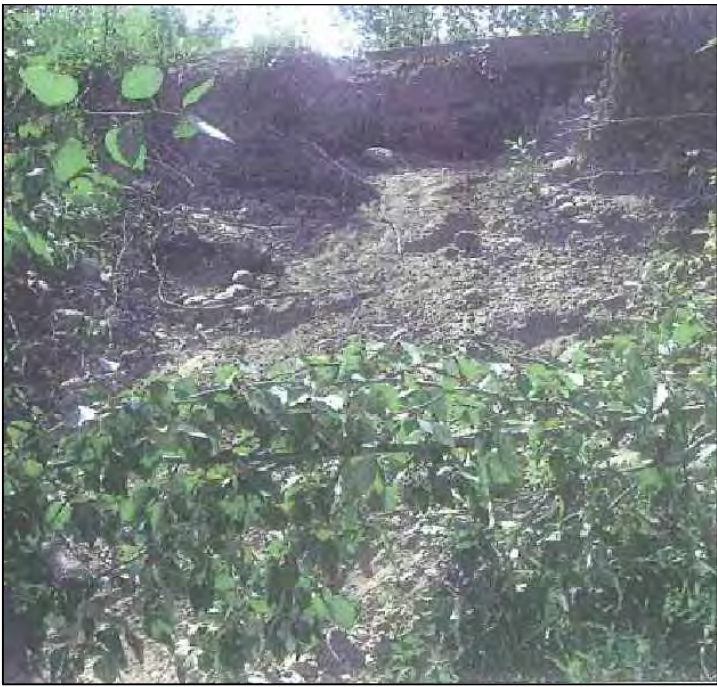
PHOTOGRAPH 84 (SHORTLY AFTER 2006 FLOODING): WASHOUT AND UNDERMINING PEDESTRIAN TRAIL AT NORTH END OF STUDY AREA 3, TAKEN FROM RIVER BACK TOE FACING WEST

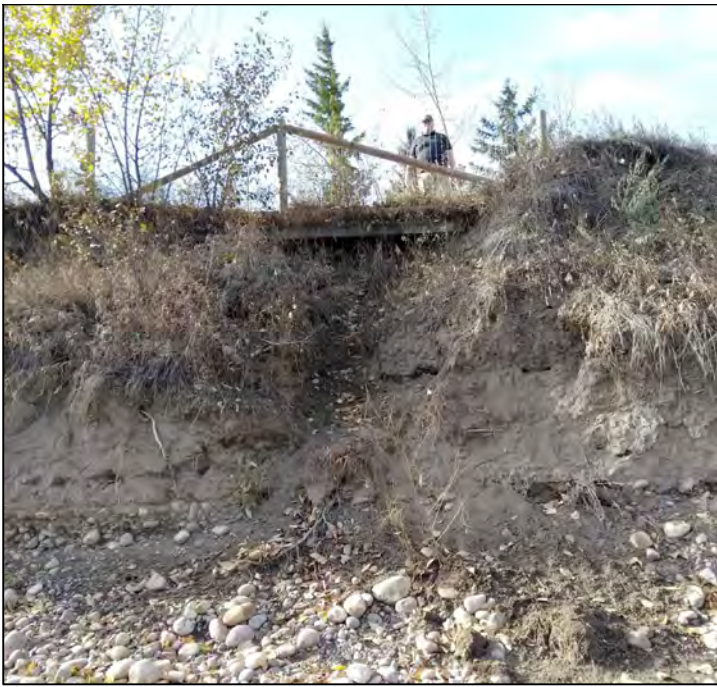
PHOTOGRAPH 84 (2018): WASHOUT AND UNDERMINING PEDESTRIAN TRAIL, FACING WEST

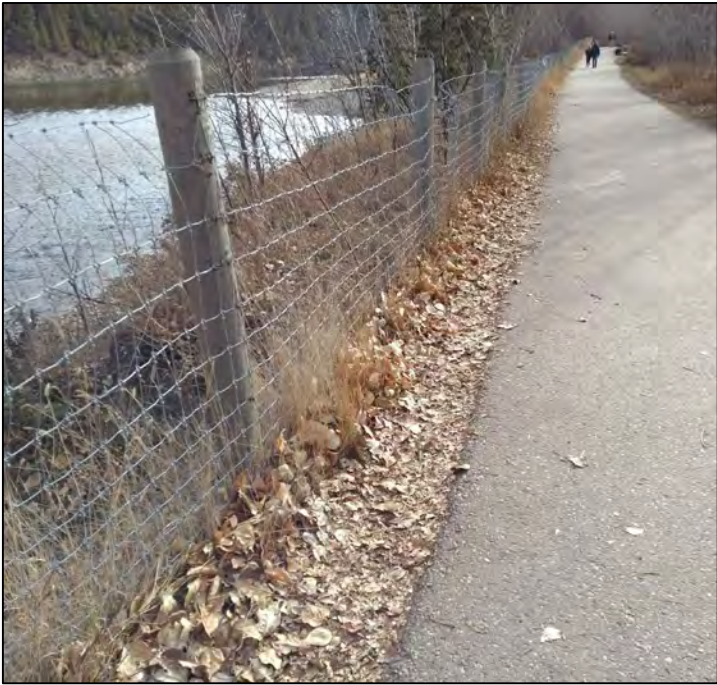
PHOTOGRAPH 93 (2018): PEDESTRIAN PATH AND FENCE AT THE CREST OF SLOPE NEAR WASHOUT AREA OF STUDY AREA 3, FACING SOUTH

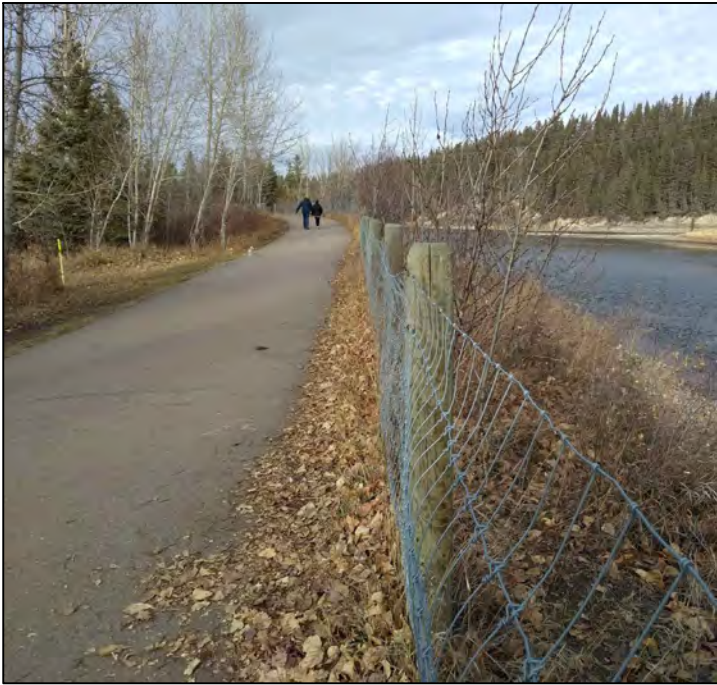
PHOTOGRAPH 96 (2018): PEDESTRIAN PATH AND FENCE NEAR THE CREST OF SLOPE AT STUDY AREA 3, FACING NORTH

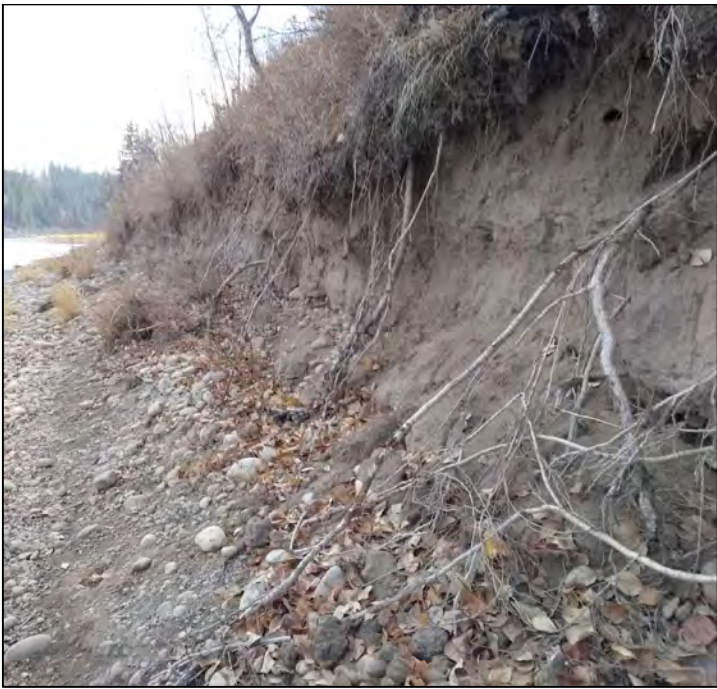
PHOTOGRAPH 116 (2018): VERTICAL CUT OF WEST RIVER BANK AT THE NORTH END OF STUDY AREA 3, FACING SOUTH

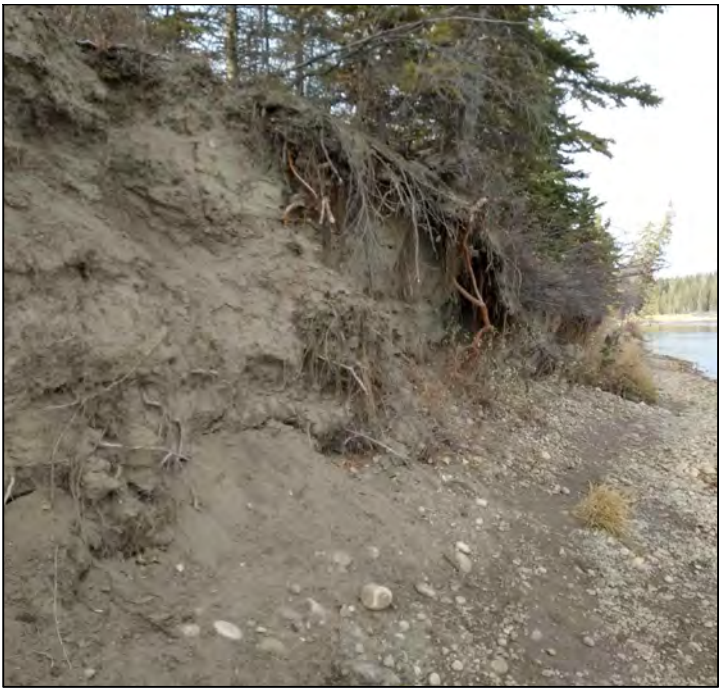
PHOTOGRAPH 118 (2018): VERTICAL CUT OF WEST RIVER BANK AT THE NORTH END OF STUDY AREA 3, FACING NORTH

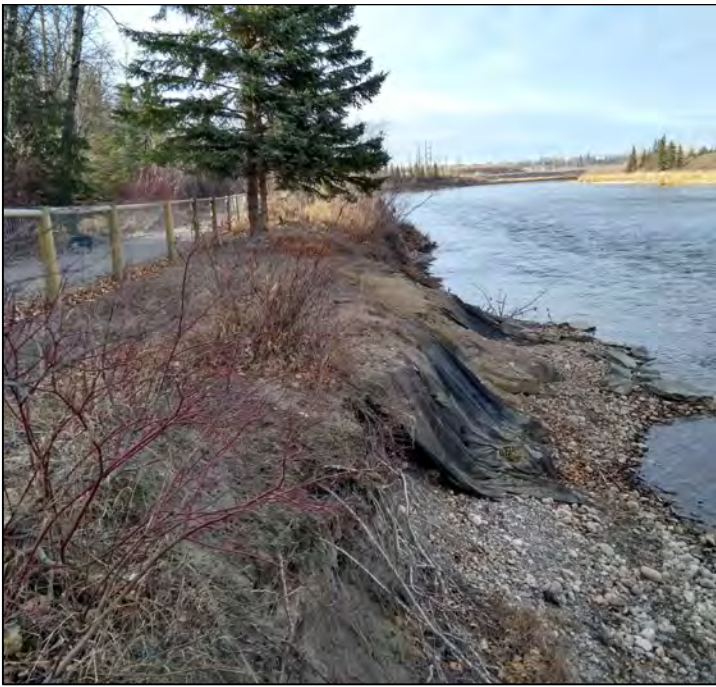
PHOTOGRAPH 128 (2018): CREST OF SOUTH RIVER BANK AT THE EAST END OF STUDY AREA 4, FACING WEST WITH THE FLOW OF RIVER

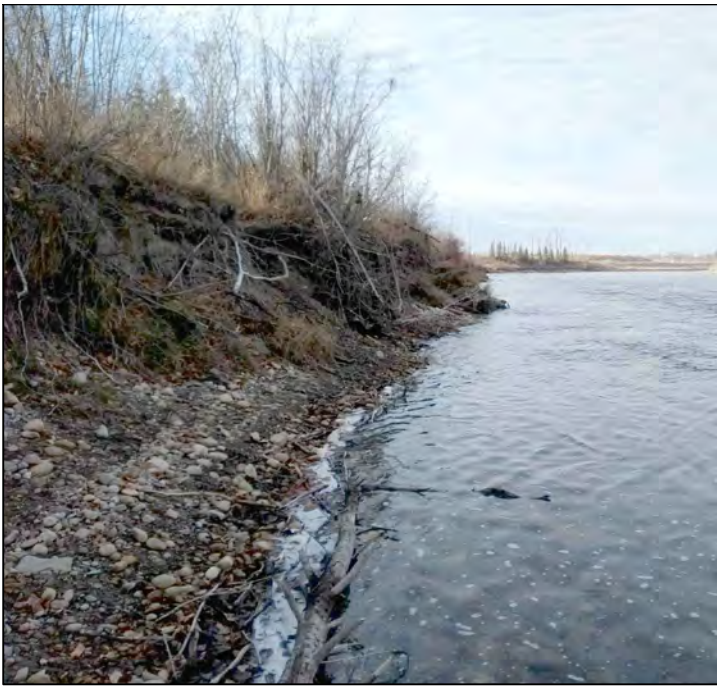
PHOTOGRAPH 136 (2018): SOUTH RIVER BANK AT THE WEST END OF STUDY AREA 4, FACING WEST WITH THE FLOW OF RIVER

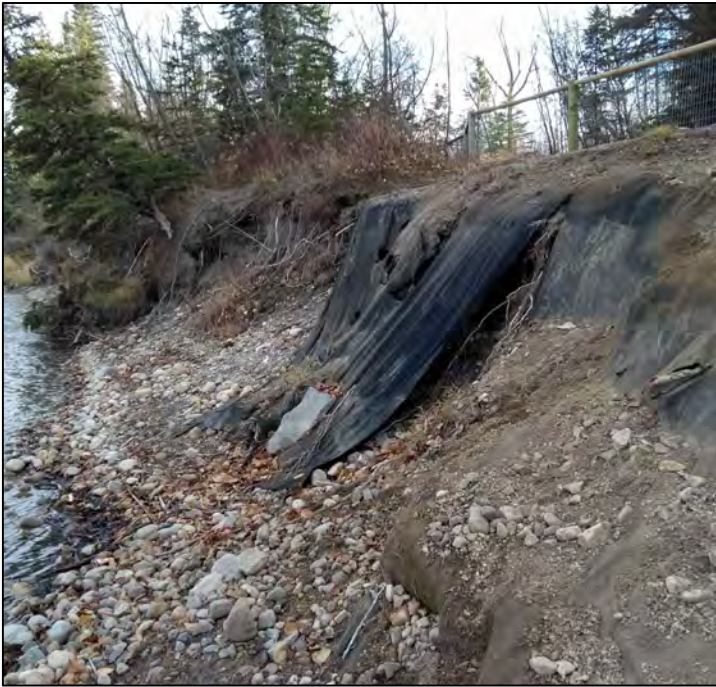
PHOTOGRAPH 137 (2018): SOUTH RIVER BANK AND GEOTEXTILE AT THE CENTER OF STUDY AREA 4, FACING EAST AGAINST THE FLOW OF RIVER

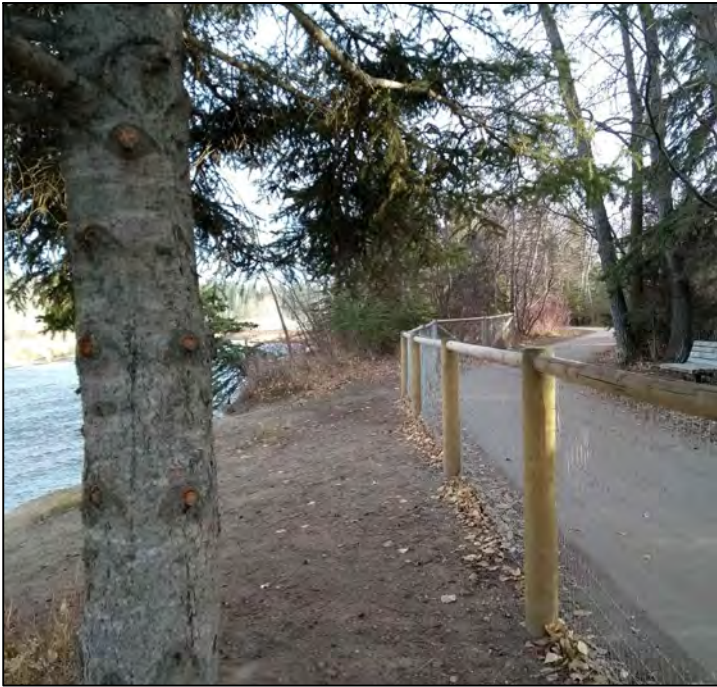
PHOTOGRAPH 141 (2018): PEDESTRIAN PATH, FENCE AND CREST AREA AT THE WEST END OF STUDY AREA 4, FACING EAST

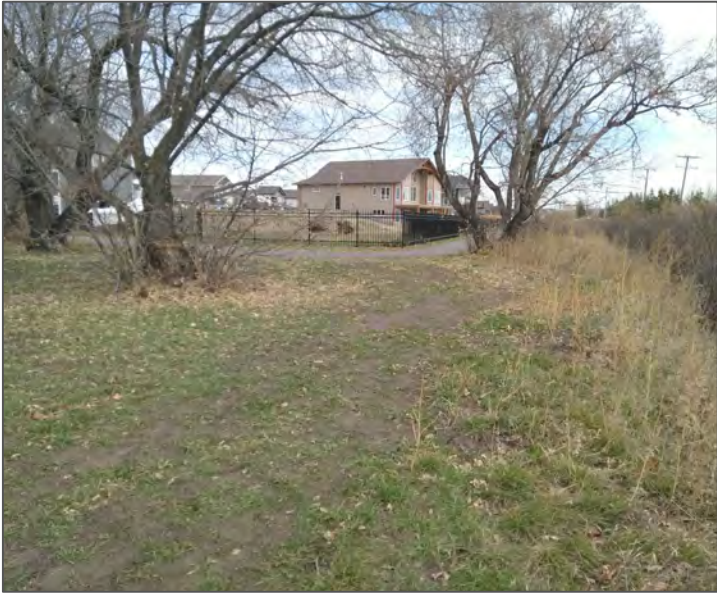
PHOTOGRAPH 4 (2018): CREST NEAR THE STEEPEST POINT OF SLOPE, FACING EAST

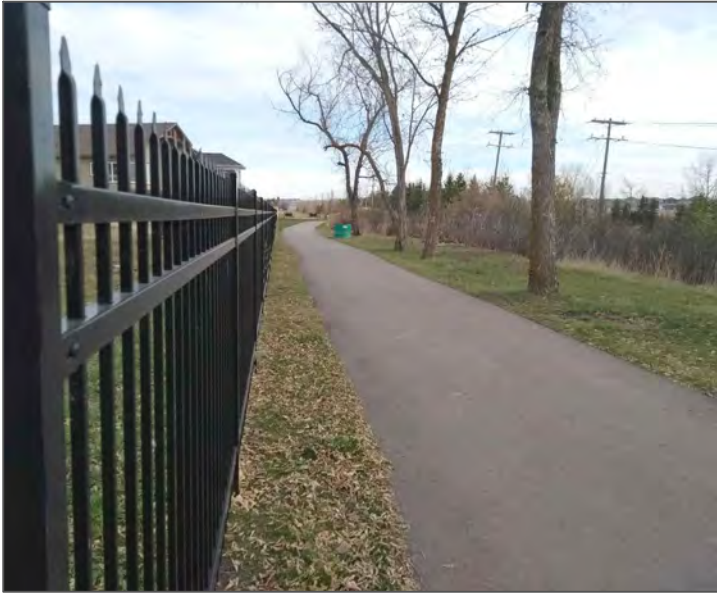
PHOTOGRAPH 7 (2018): NEWLY CONSTRUCTED STRAIGHT FENCE PARALLEL TO SLOPE, FACING EAST
