CLIENT:		SITE PLAN	
			CITY OF RED DEER SLOPE STABILITY EVALUATION EAST RED DEER RIVER BANK (OPPOSITE 3 MILE BEND)	
	DRAWN:	CHK'D:	REV #:	DATE:
	PS	MDB	2	APRIL 2019
SCALE:		JOB NO.		DRAWING NO.
1:7500		RD6500-9/10		FIGURE 9/10-1

**CITY OF RED DEER
SLOPE MONITORING PROGRAM
2018 INSPECTION REPORT**

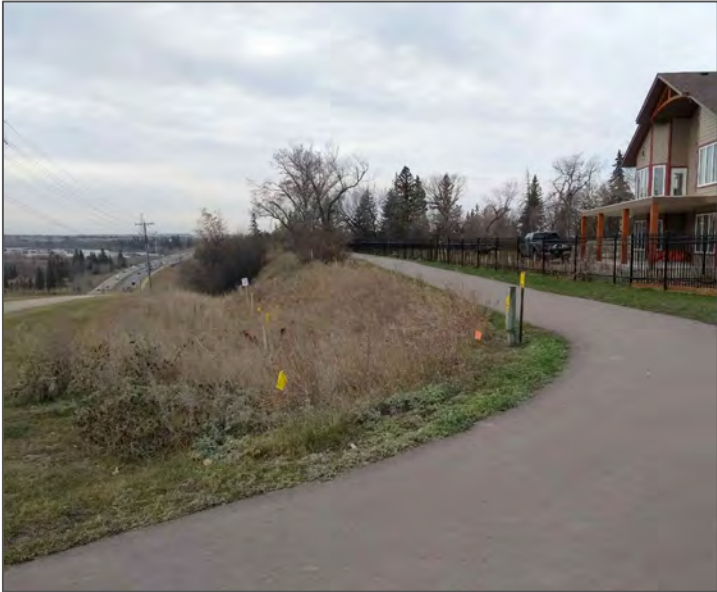
PHOTOGRAPH 13 (2018): EAST EXTENT OF SLOPE CREST, FACING NORTHWEST

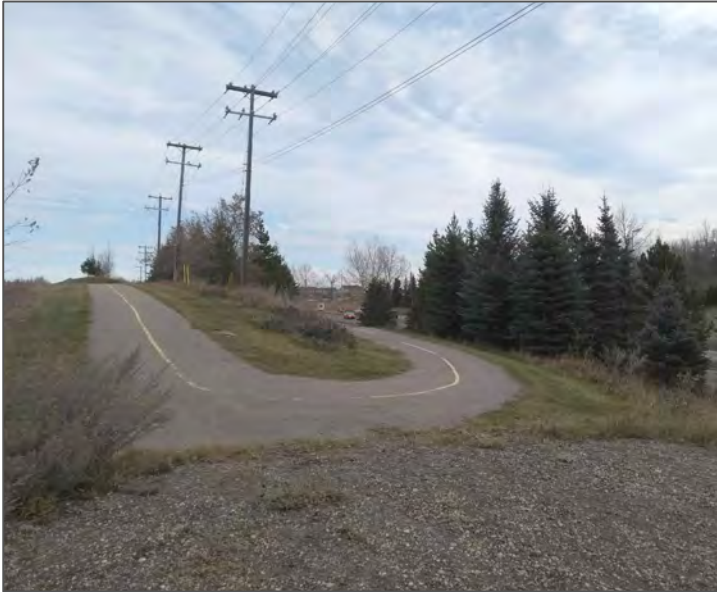
PHOTOGRAPH 16 (2018): TRAIL SWITCH BACK, TAKEN FROM FROM STORM SEWER VAULT AREA, FACING SOUTHEAST

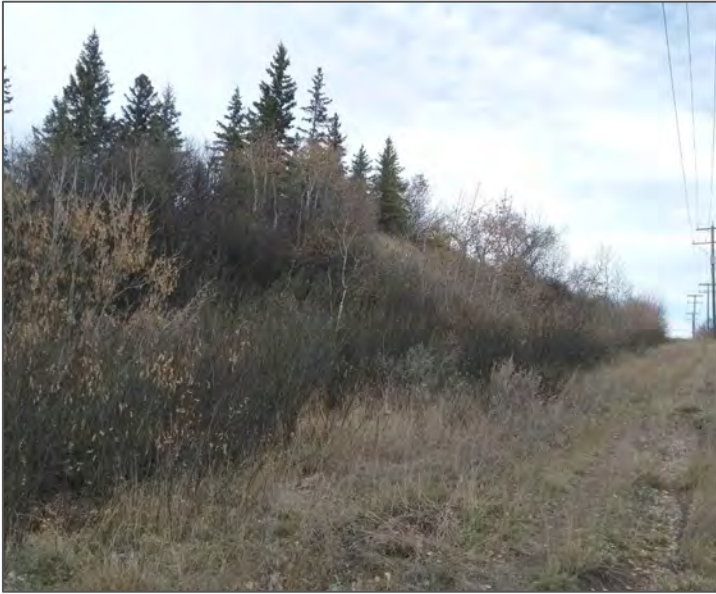
PHOTOGRAPH 19 (2018): SLOPE FACE FROM WEST EXTENT, FACING NORTHEAST

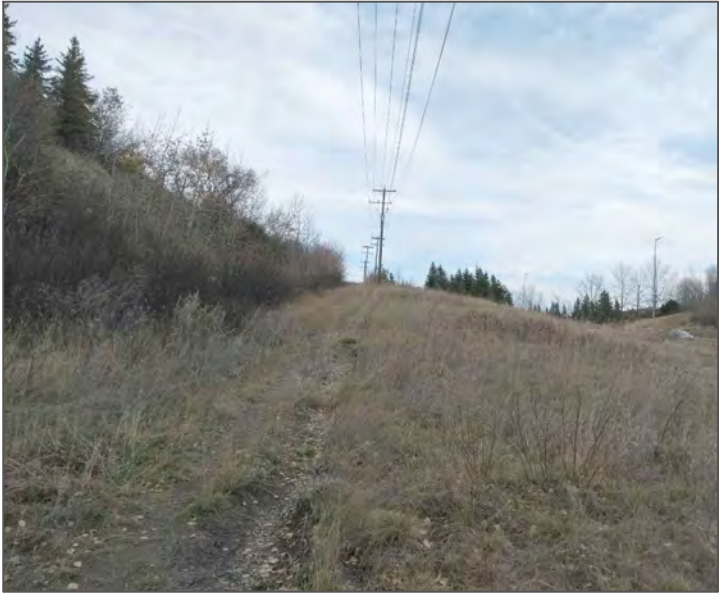
PHOTOGRAPH 20 (2018): SLOPE ALONG STORM SEWER / OLD ROAD ROW ALIGNMENT, FACING EAST

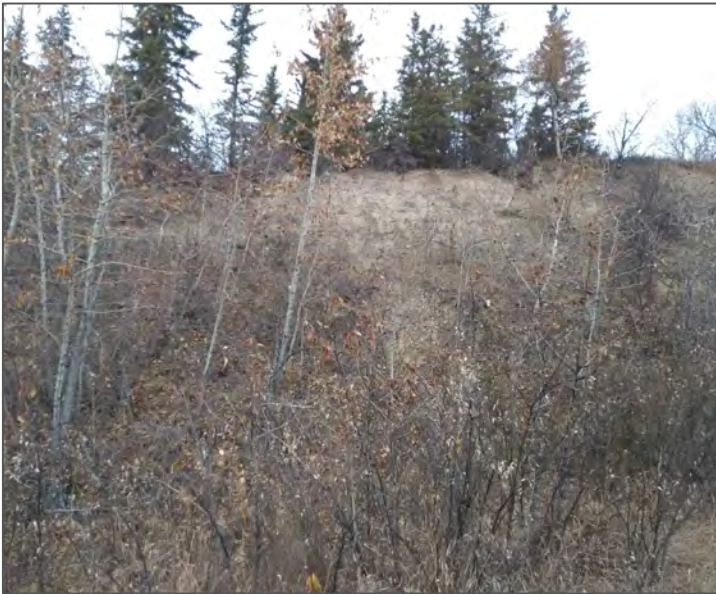
PHOTOGRAPH 21 (2018): BARREN UPPER SLOPE FACE, FACING NORTH

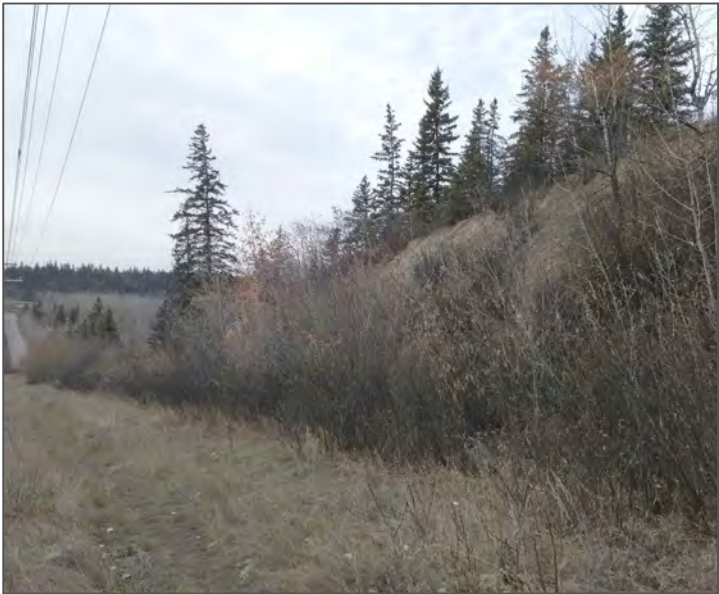
PHOTOGRAPH 24 (2018): STEEP SLOPE IN THE WEST EXTENT OF STUDY AREA, FACING NORTHWEST

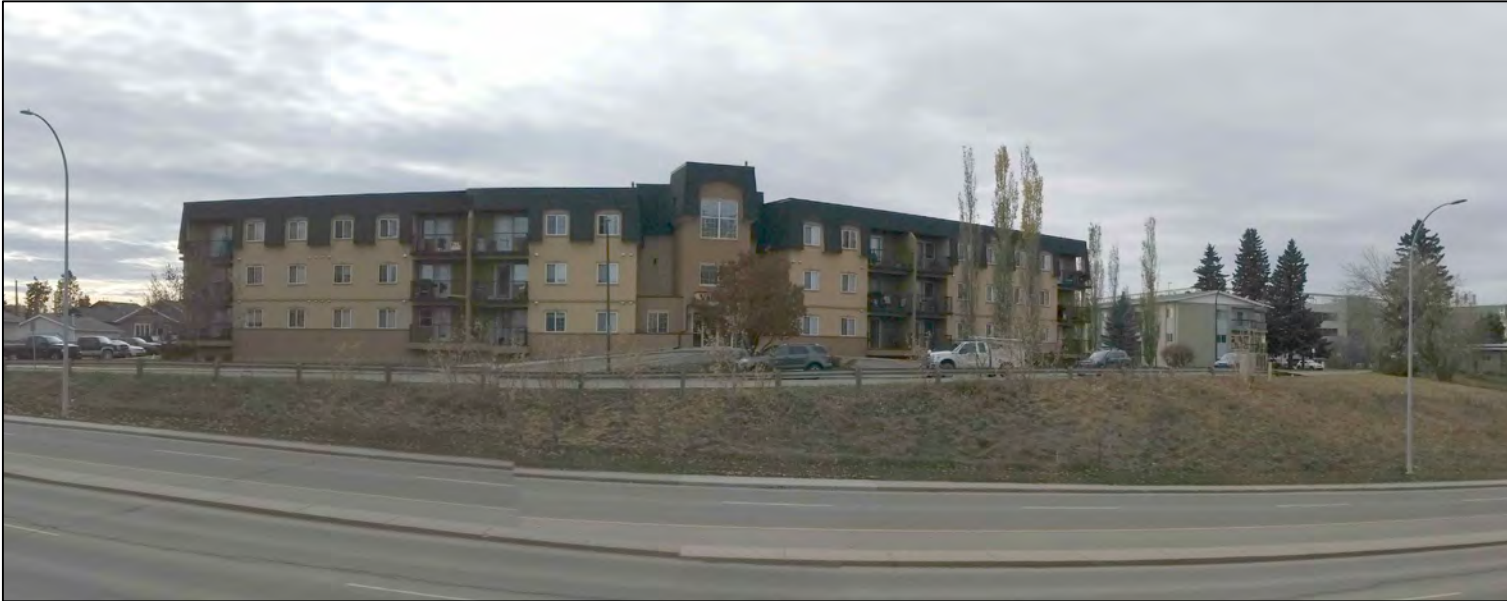
PHOTOGRAPH 16 (2018): SLOPE OF INTEREST BETWEEN GAETZ AVE AND SERVICE ROAD, TAKEN FROM CORNER OF NORTHWEST PARKING LOT AT 3731 50TH AVE, FACING WEST

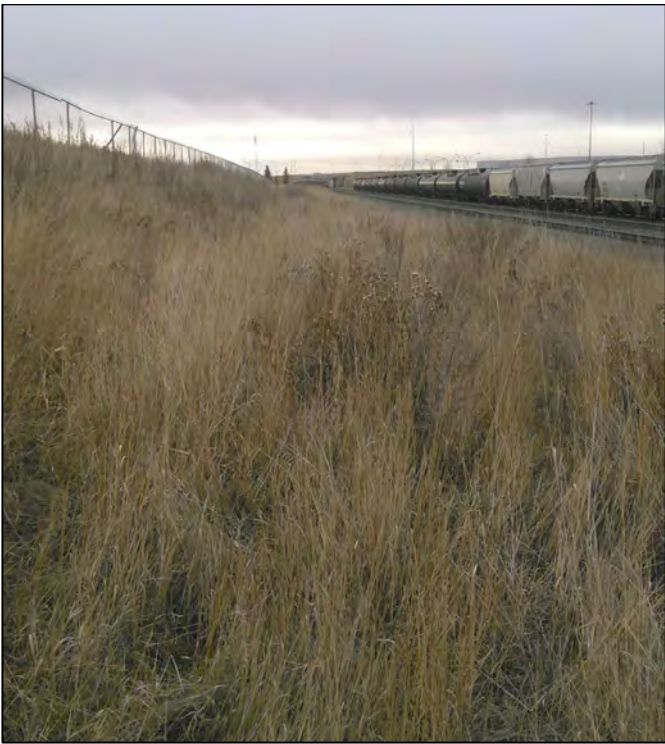
PHOTOGRAPH 4 (2018): SLOPE ALONG THE RAILWAY LINE, LOOKING ACROSS THE SLOPE, FACING SOUTH

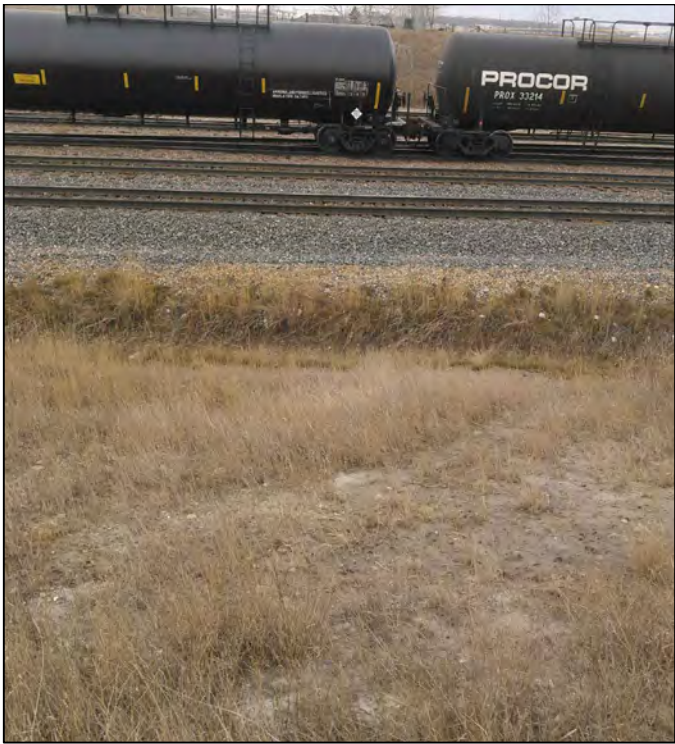
PHOTOGRAPH 10 (2018): SLOPE ALONG THE RAILWAY LINE, LOOKING DOWN THE SLOPE, FACING WEST

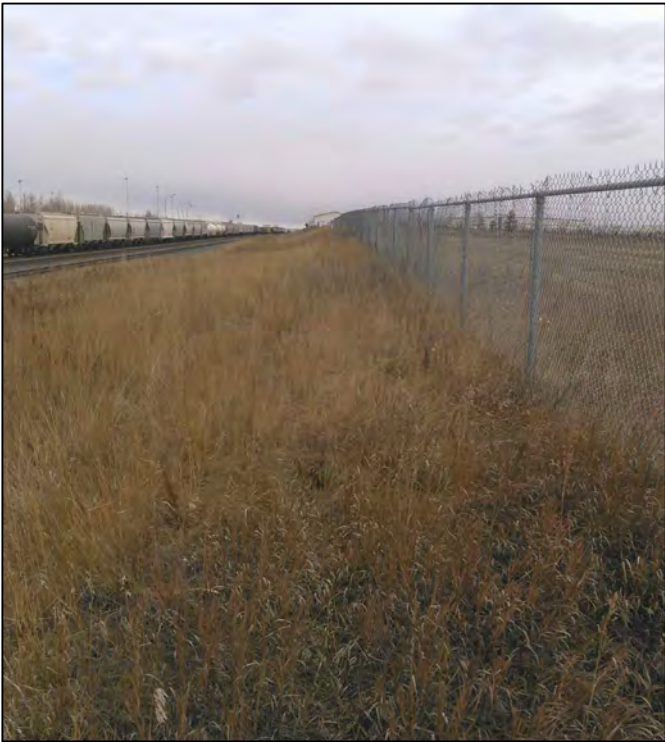
PHOTOGRAPH 12 (2018): SLOPE ALONG THE RAILWAY LINE, LOOKING ACROSS THE SLOPE, FACING NORTH

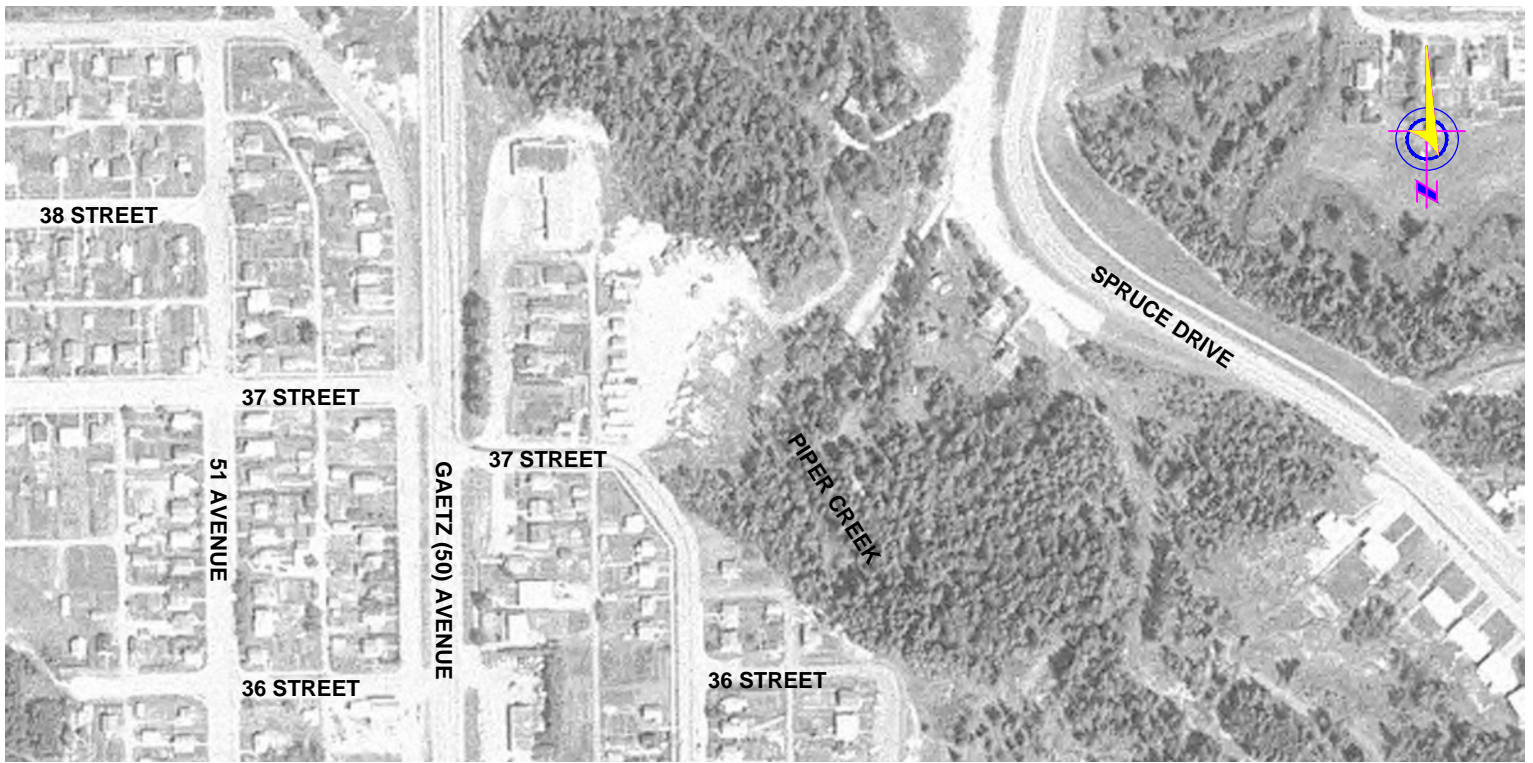
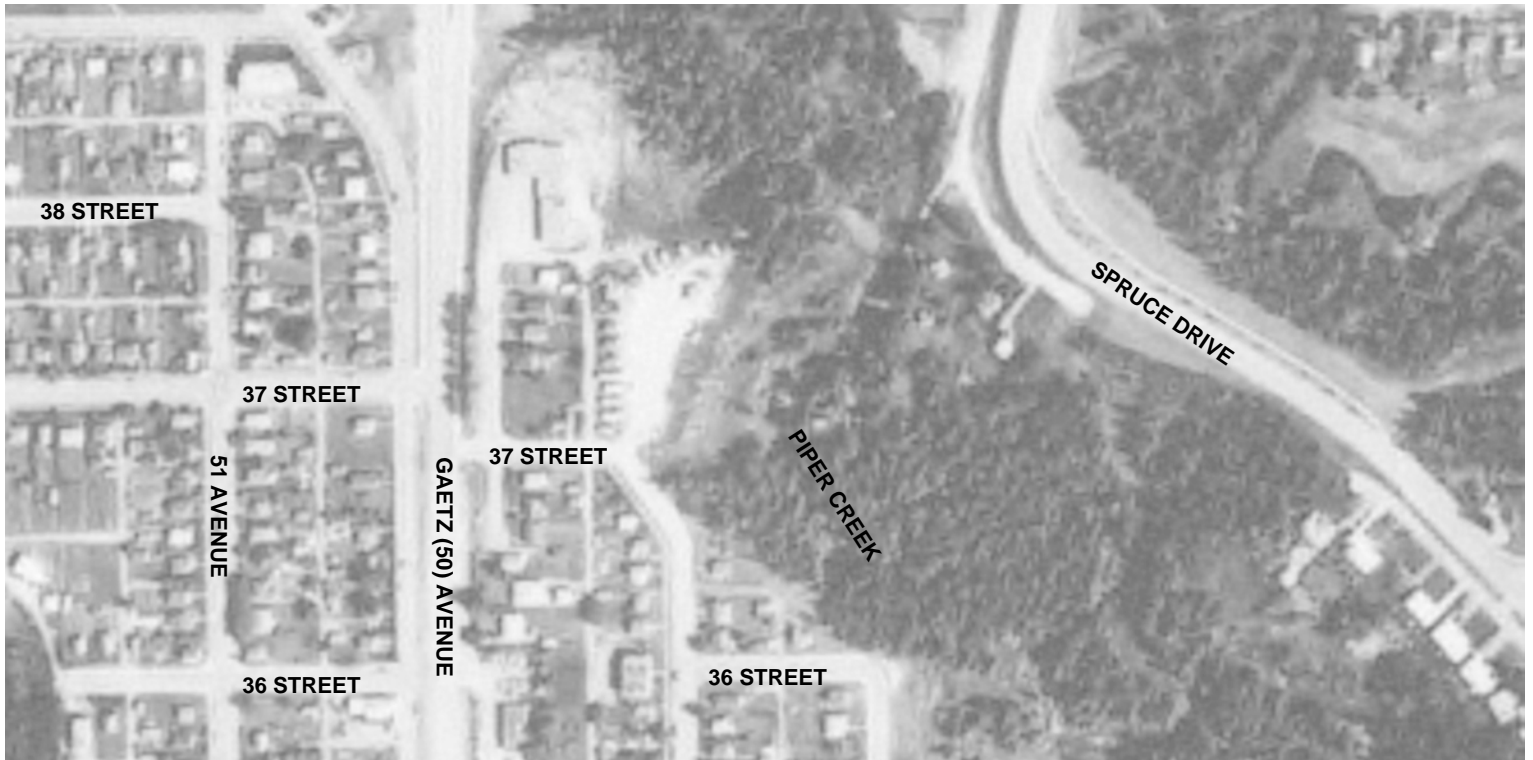
CLIENT:		AERIAL PHOTOGRAPHS			
			CITY OF RED DEER SLOPE STABILITY EVALUATION FORMER ELKS CLUB & 36 STREET LANDSLIDE SITES			
			DRAWN:	CHK'D.:	REV #:	DATE:
			PS	MDB	2	APRIL 2019
		SCALE:	JOB NO.		DRAWING NO.	
		1:4000	RD6500-19		FIGURE 19-4A

Year	Description
1962	This shows the Elks site prior to the mid 1960s landslide
1969	This shows the Elks site shortly after the landslide and indicates the extent of the berm
2001	Shows the site condition 18 years ago.
2016	Shows the present slope conditions in the area.

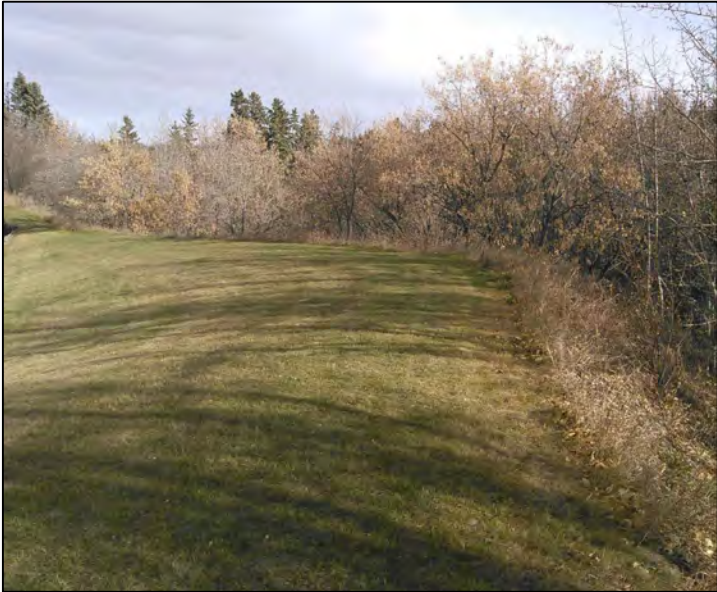
PHOTOGRAPH 6 (2018): CREST OF THE SLOPE, FACING NORTHEAST

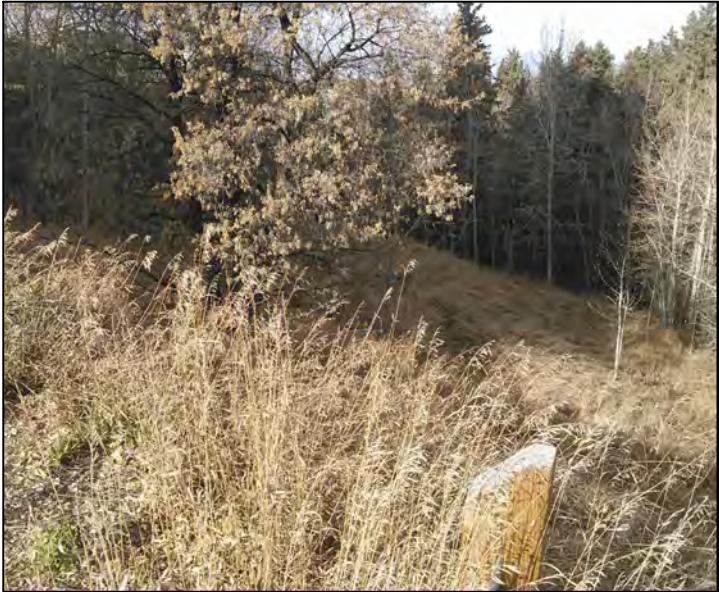
PHOTOGRAPH 15 (2018): SLOPE FACE, TAKEN FROM CREST OF THE SLOPE, FACING NORTH

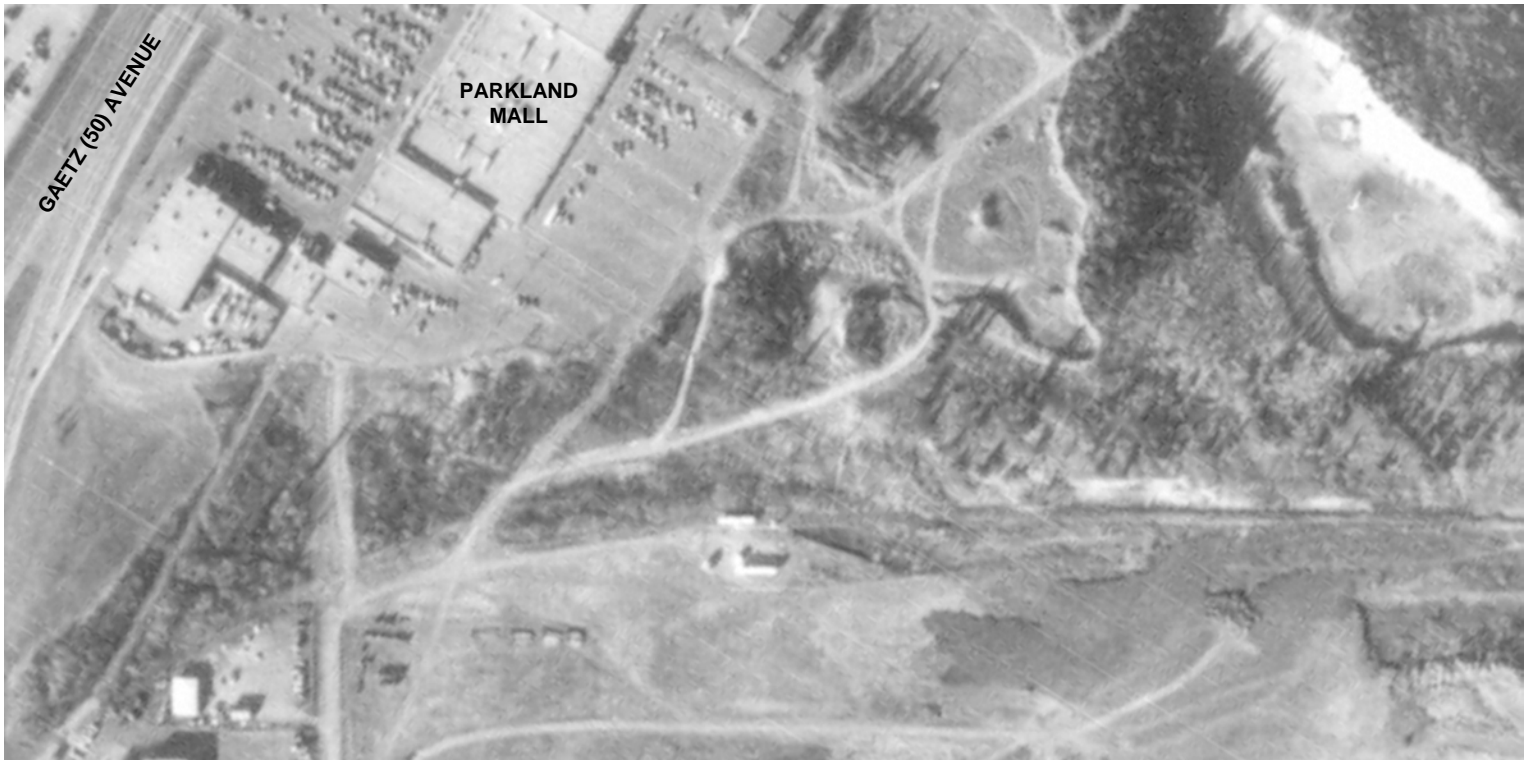
Aerial photography is provided on Figures 20-5A and 20-5B, for the years listed in following table. The 2001 aerial photo shows the final extent of disturbance on the slope face.

NOTE: AERIAL PHOTOGRAPH OBTAINED FROM ALBERTA ENVIRONMENT AND PARKS, DATED NOVEMBER 17, 1975.

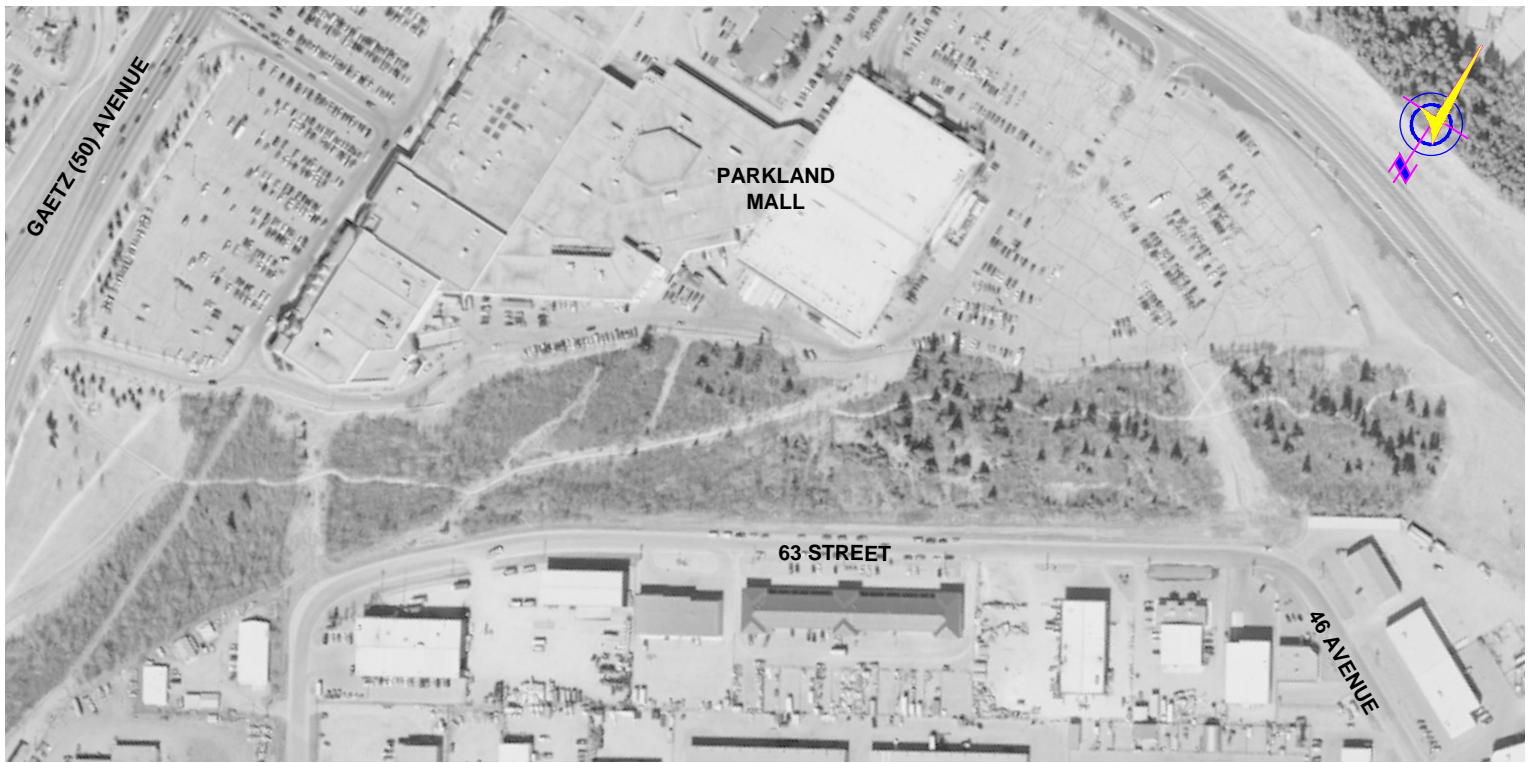
NOTE: AERIAL PHOTOGRAPH OBTAINED FROM CITY OF RED DEER WEB MAP, DATED 2001.

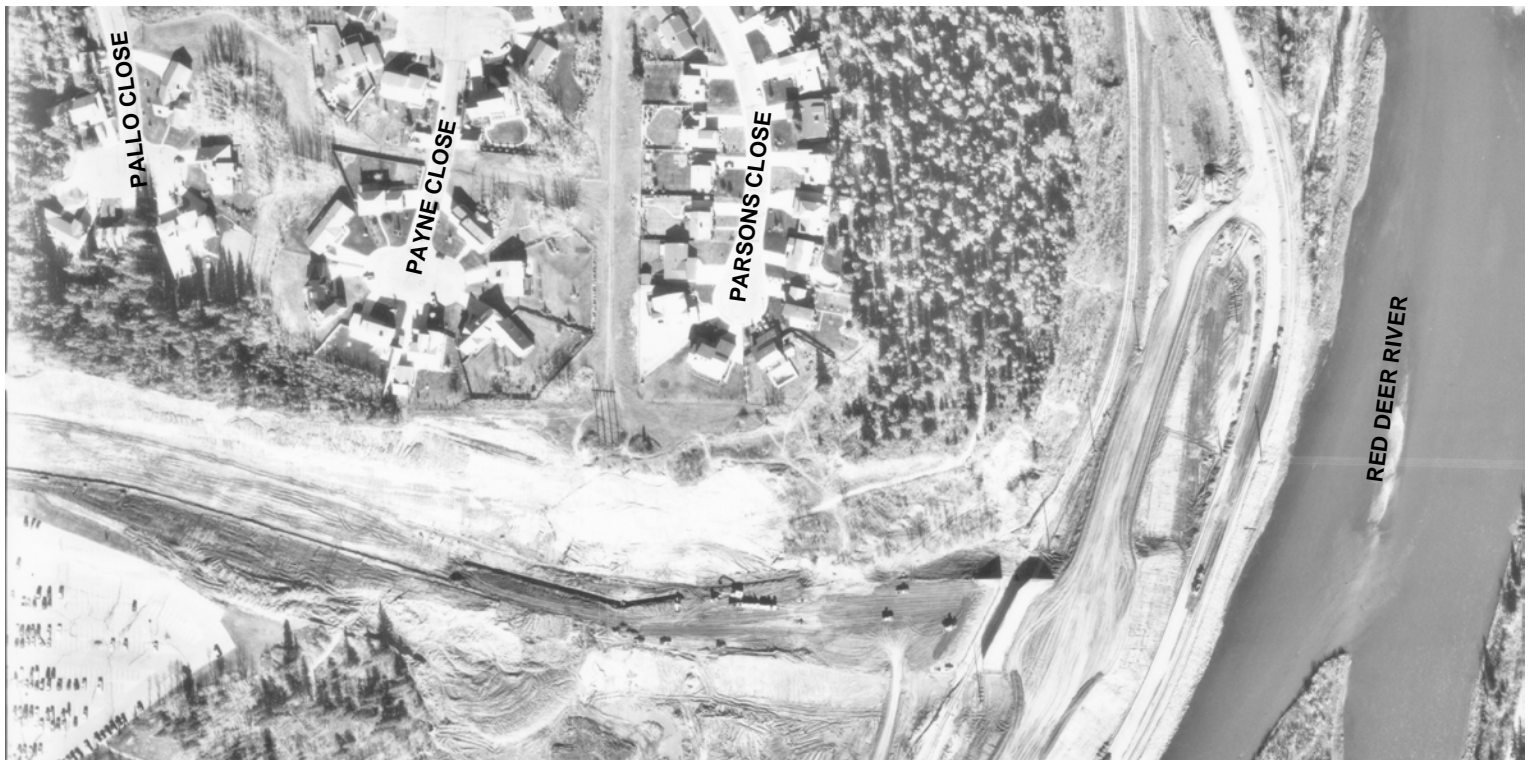
Aerial photography is provided on Figures 21-4A and 21-4B, for the years listed in following table. The 1986 aerial photo is the only evidence of the landslide location that is presently available.

Year	Description
1985	Shows the original site condition prior to the road construction.
1986	Shows the condition shortly after the 1986 landslides. The landslide scarps are visible.
2001	Shows the condition of the final 67 th alignment with the toe berm in place.
2016	Shows the present site condition.

NOTE: AERIAL PHOTOGRAPH OBTAINED FROM ALBERTA ENVIRONMENT AND PARKS, DATED OCTOBER 15, 1986.

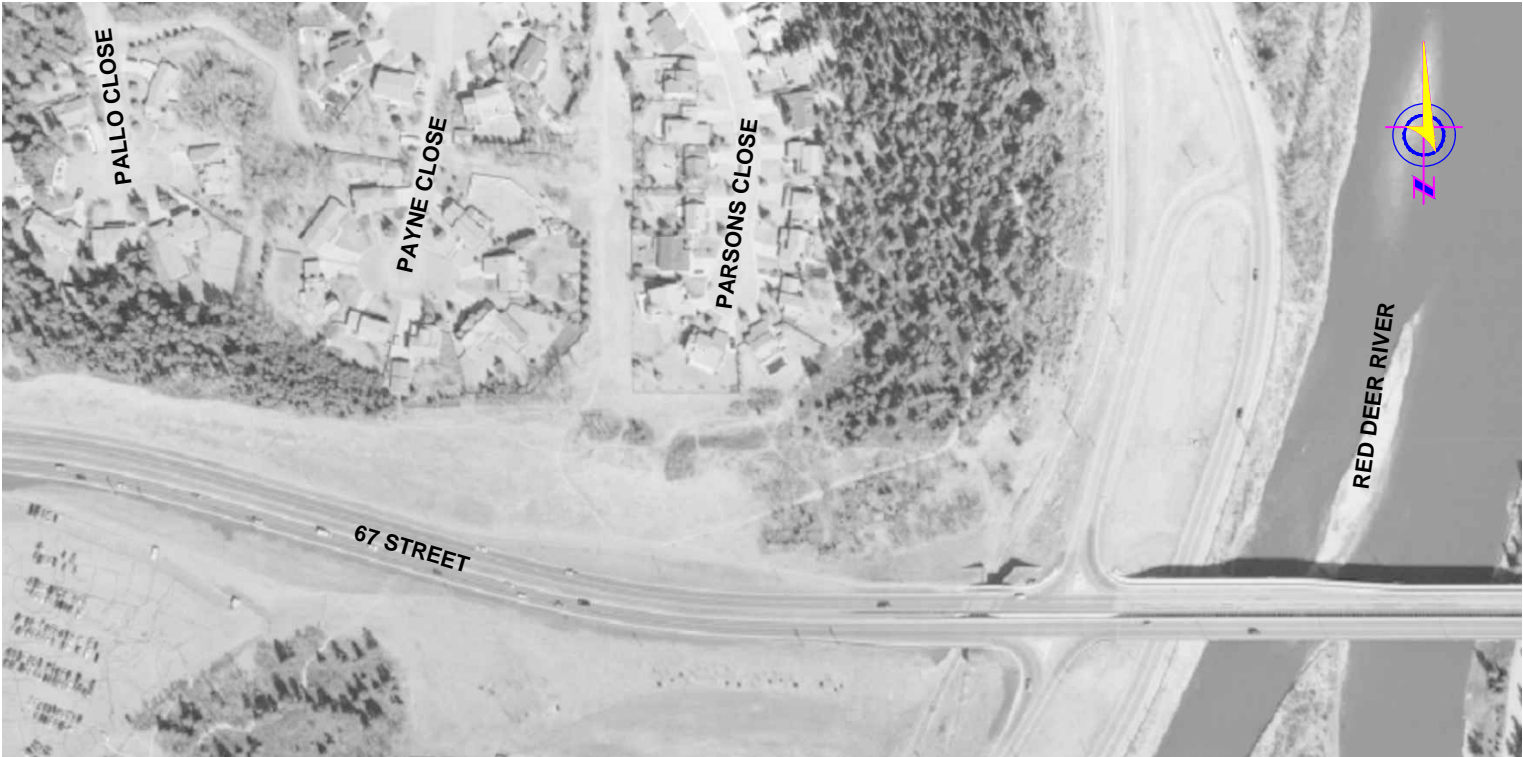
NOTE: AERIAL PHOTOGRAPH OBTAINED FROM CITY OF RED DEER WEB MAP, DATED 2001.

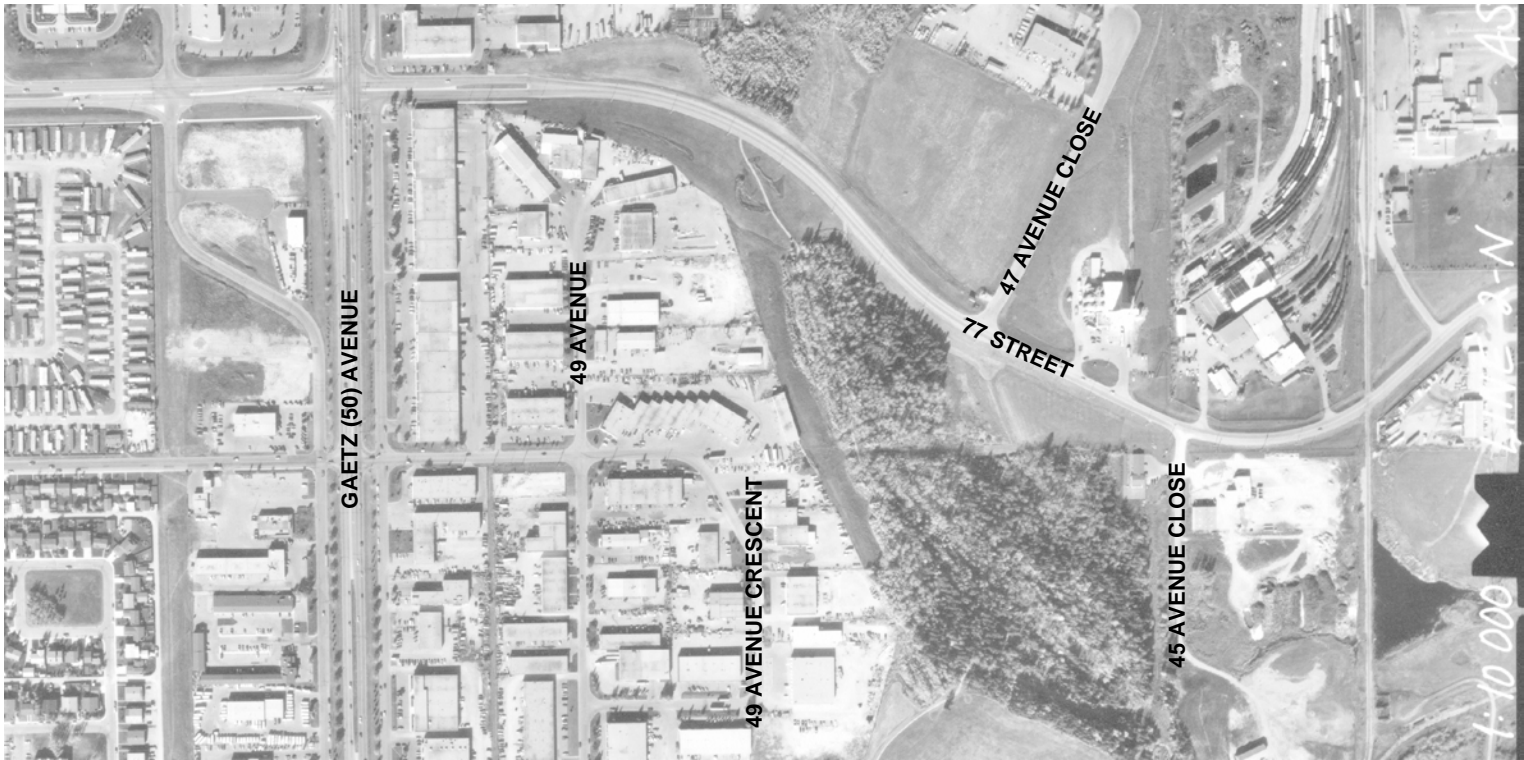
NOTE: AERIAL PHOTOGRAPH OBTAINED FROM ALBERTA ENVIRONMENT AND PARKS, DATED SEPTEMBER 27, 1991.

Year	Description
1973	Shows the original site condition of the ravine and slope prior to 77 th Street construction.
1991	Shows the road cut for the 77 th Street construction including signs of two landslides.
2001	Shows the site condition over 15 years ago with no sign of the old landslide..
2016	Shows the present Site condition.

The south cut slopes overlooking 77th Street have been subject to shallow slumps at two areas in the past 40 years since the road was constructed. The west slump was a long narrow failure about two-thirds of the way up the slope and the east slump was a larger crescent shaped slide which cut across the existing bike path. The initial road cut along the south side of the original ravine were considered to be too steep for the native soils in the upper slope. The grade was flattened as much as the road right-of-way would allow and the original landslide sites were re-graded and landscaped. In 1979, a 300 mm sub-drainage pipe was installed in the ditch immediately south of 77th Street as shown on Figure 22-1. In 1991, two slumps re-occurred at the site as shown in the 1991 Aerial on Figure 22-4A. These areas were provided with french drains up the slope to the slide areas as shown on Figure 22-1. These slope drains were tied into the 1979 sub-drain in the south ditch. Both areas was re-graded and the bike path was realigned to the east of slide area. The long narrow west failure appears to have slumped again and is currently visible at the site. The east failure is no longer visible in the field or on more recent aerial imagery.

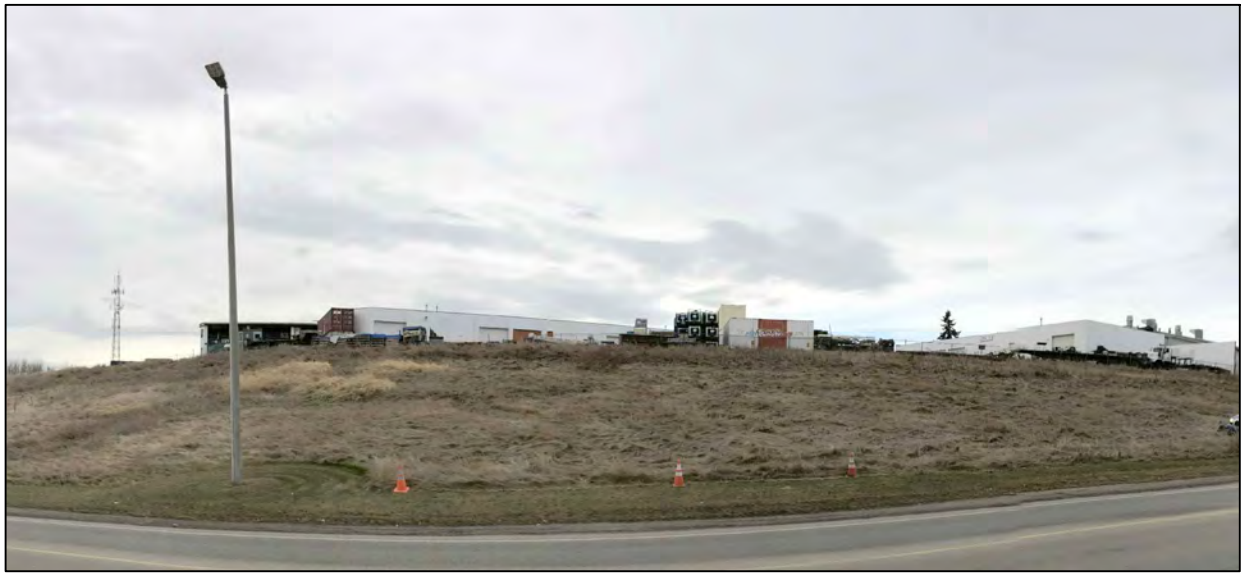
**PHOTOGRAPH 1 (2018): SLOPE ON THE SOUTH OF 77 STREET,
TAKEN FROM ACROSS THE STREET, FACING SOUTH**

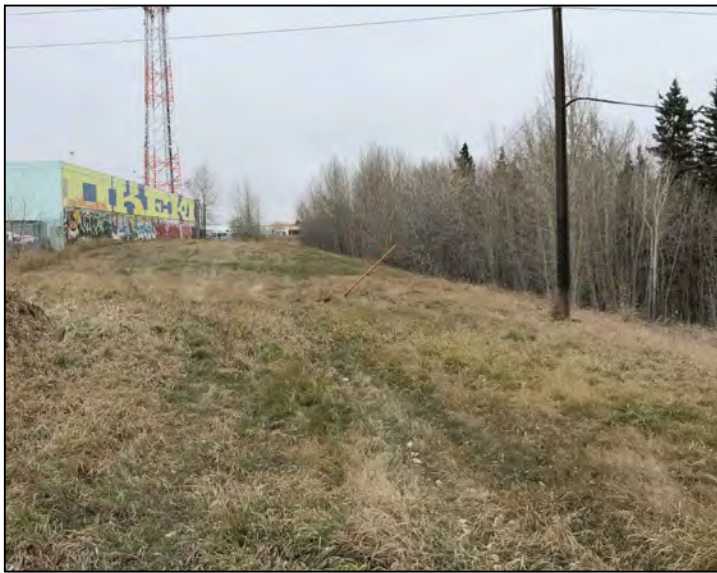
**PHOTOGRAPH 19 (2018): CREST OF SLOPE, LOOKING ACROSS
THE CREST, FACING NORTH**

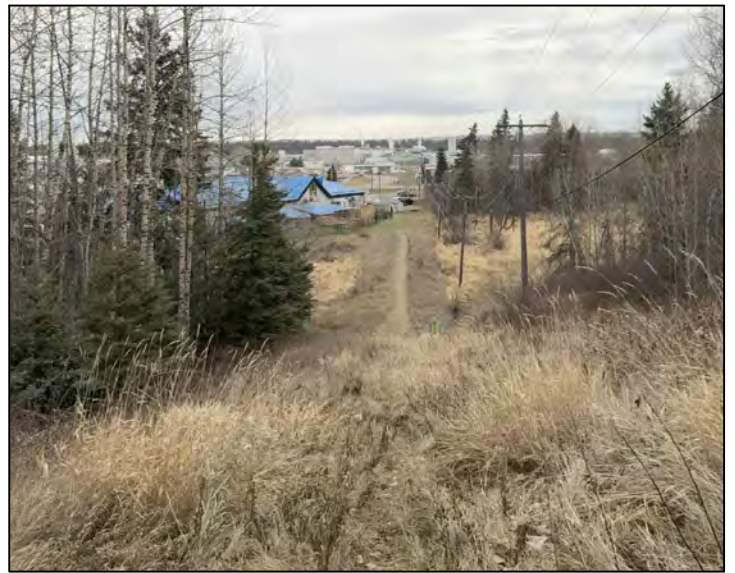
**PHOTOGRAPH 21 (2018): SLOPE ALONG THE POWER LINE,
LOOKING DOWN THE SLOPE, FACING EAST**

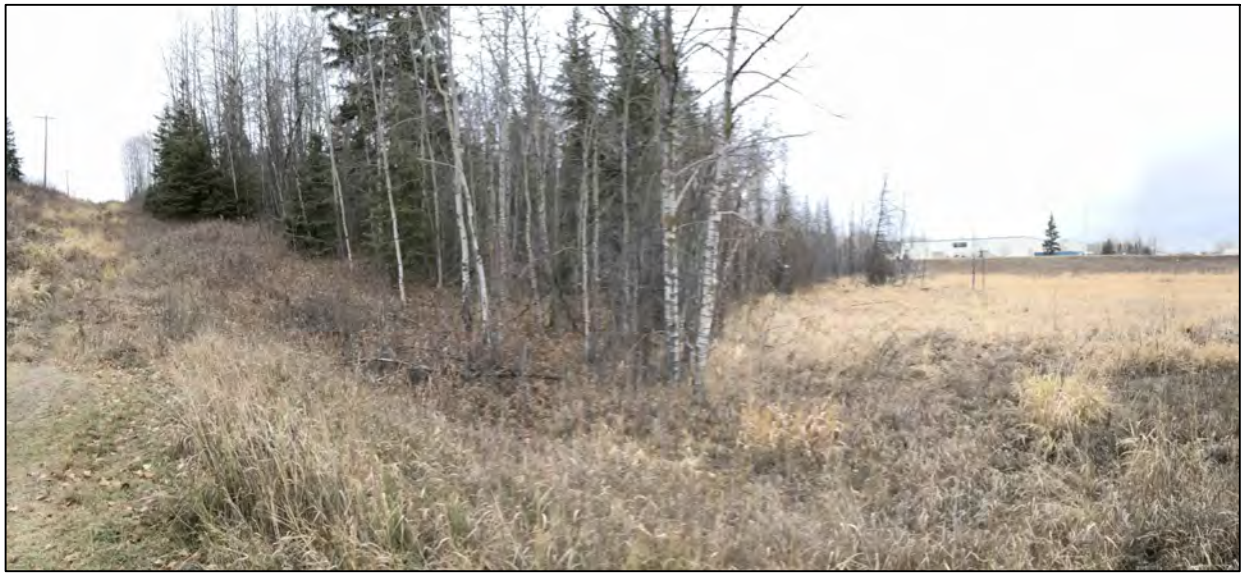
**PHOTOGRAPH 24 (2018): SLOUGH NEXT TO THE TOE OF SLOPE,
FACING NORTHWEST**

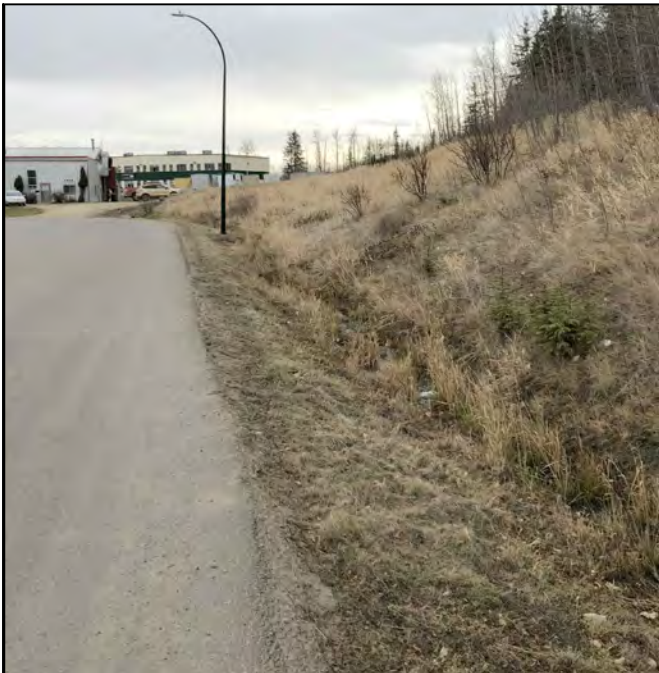
The face of the river terrace bench along 45th Avenue Close is relatively steep, but the exposed soil is very stiff clay till. This slope is considered to be stable in the short-term and marginally stable in the long-term. A small, localized block failure could occur in this slope; and it would likely fill in the existing road side ditch or even spill out onto the edge of 45th Avenue Close. However, this river terrace is isolated from the main slope by the bench area, so any instability along this slope would not have any impact on the upper slope.

**PHOTOGRAPH 35 (2018): TOE OF SLOPE ALONG 45 AVENUE
CLOSE, FACING SOUTH**

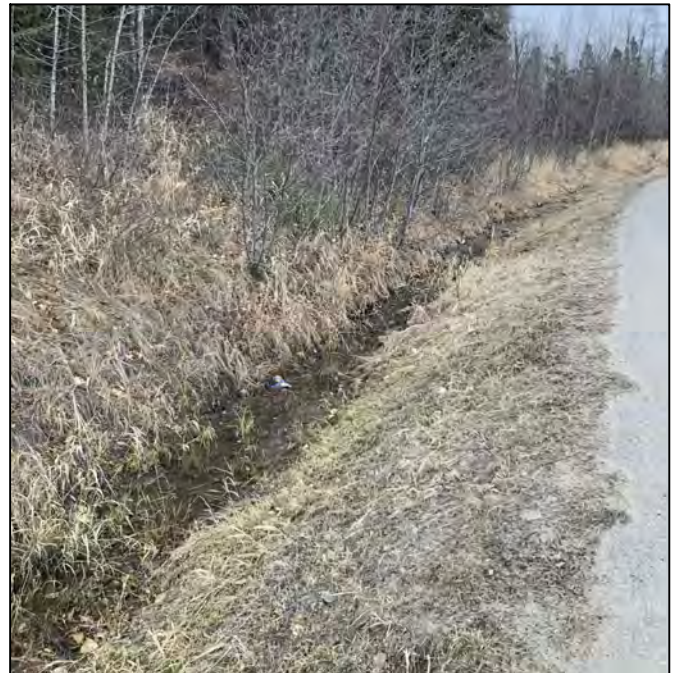
**PHOTOGRAPH 36 (2018): TOE OF SLOPE ALONG 45 AVENUE
CLOSE, FACING NORTHWEST**

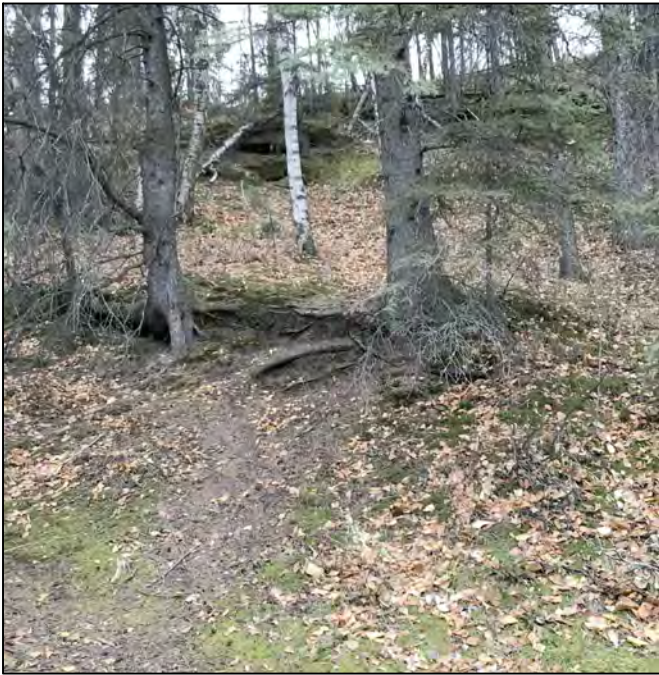
PHOTOGRAPH 50 (2018): VEGETATION GROWN ON THE SLOPE, FACING SOUTH

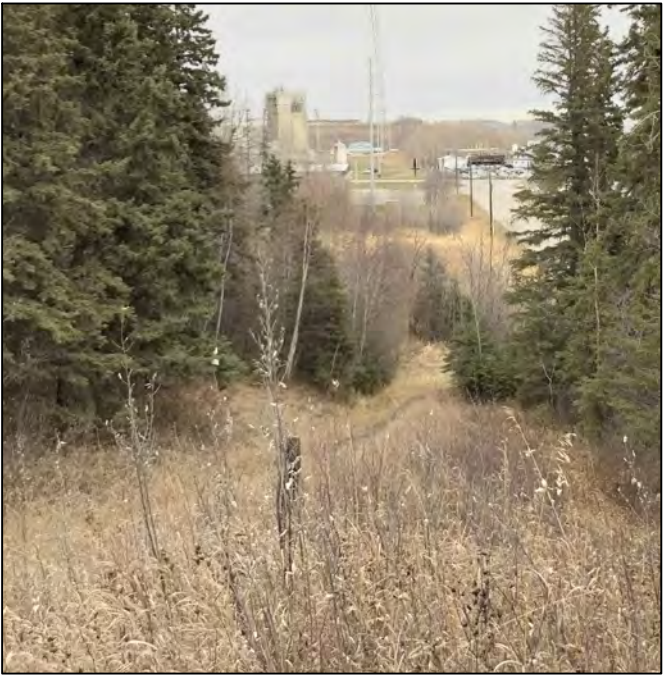
PHOTOGRAPH 54 (2018): SLOPE ON THE SOUTHEAST SIDE OF STUDY AREA, LOOKING DOWN THE SLOPE, FACING NORTH

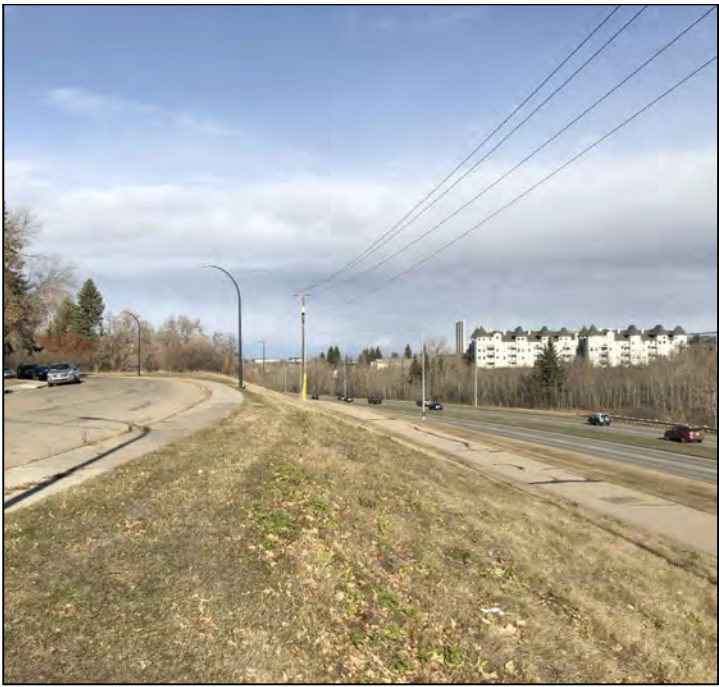
PHOTOGRAPH 4 (2018): SLOPE AND WALKING TRAIL BETWEEN 54 AVENUE CLOSE AND TAYLOR DRIVE, FACING NORTH

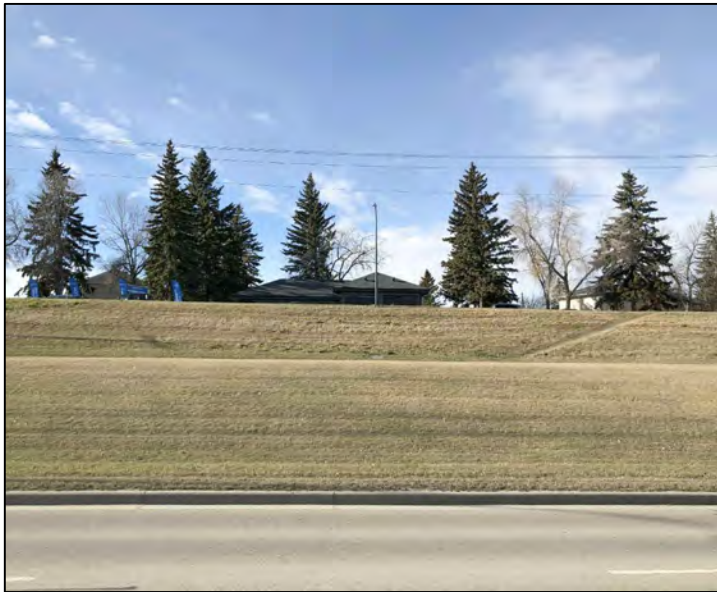
PHOTOGRAPH 10 (2018): SLOPE AND WALKING TRAIL BETWEEN 54 AVENUE CLOSE AND TAYLOR DRIVE, TAKEN FROM ACROSS TAYLOR DRIVE, FACING WEST

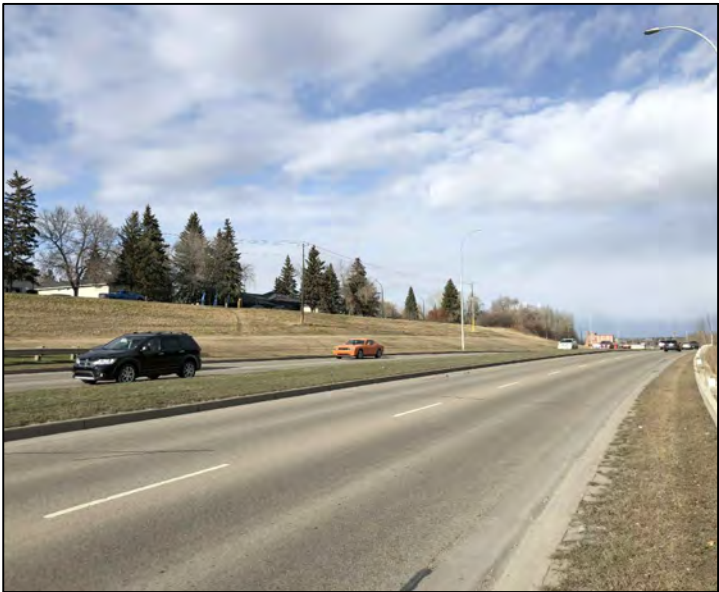
PHOTOGRAPH 28 (2018): SLOPE BETWEEN 54 AVENUE CLOSE AND TAYLOR DRIVE, TAKEN FROM ACROSS TAYLOR DRIVE, FACING NORTHWEST

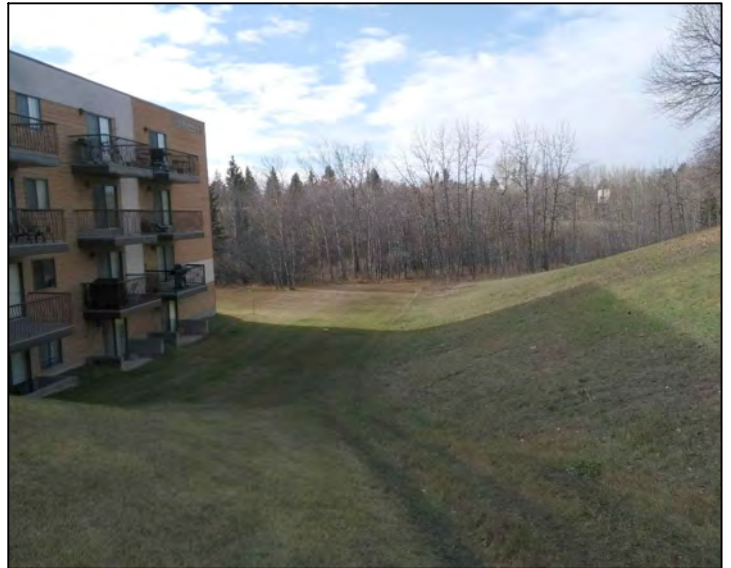
PHOTOGRAPH 18 (2018): 1982 LANDSLIDE SLOPE AREA BETWEEN APARTMENTS, FACING WEST

#P24-016	Tension cracks along crest of slope	5793504	307620	NW		Y*	1982 Landslide
#P24-018	Slope area between apartments	5793493	307642	W	Y*	Y*	1982 Landslide

Observations	Description & Location	Noticeable Change	
		Yes	No
Crest Condition	Rounded	N/A	
Slope Movement	Tension cracks between buildings at 3718 52 nd Ave	N/A	
Erosion	<ul style="list-style-type: none"> Erosion at creek bank, but a large buffer from slope toe. Exposed culvert west of north bridge from creek erosion. 	N/A	
Seepage	None observed	N/A	
Distress	Soil piled at trees near toe of 5211 39 th Street	N/A	
Other		N/A	
Instrumentation:	N/A		
Other Comments:	<ul style="list-style-type: none"> Creek rerouted in 1980s to stabilize slope and straightened through culvert when Taylor Drive built.

Discussion	<ul style="list-style-type: none">- Minor movement of fill on slope below 5211 39th Street- Signs of old movement at pavement near slope near slope reconstructed/ creek rerouted (very old cracks).
Assessment	<ul style="list-style-type: none">- Slope appears stable.
Recommendations	<ul style="list-style-type: none">- Consider site inspections every 3 years or after high water/ creek flooding event.

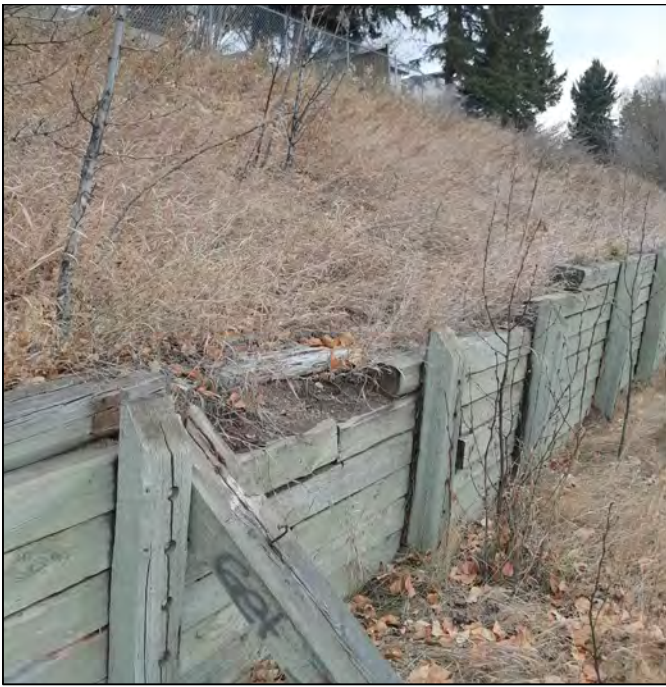
PHOTOGRAPH 67 (2018): 1991 LANDSLIDE SLOPE AND RETAINING WALL ALONG WALKING TRAIL, FACING SOUTHEAST

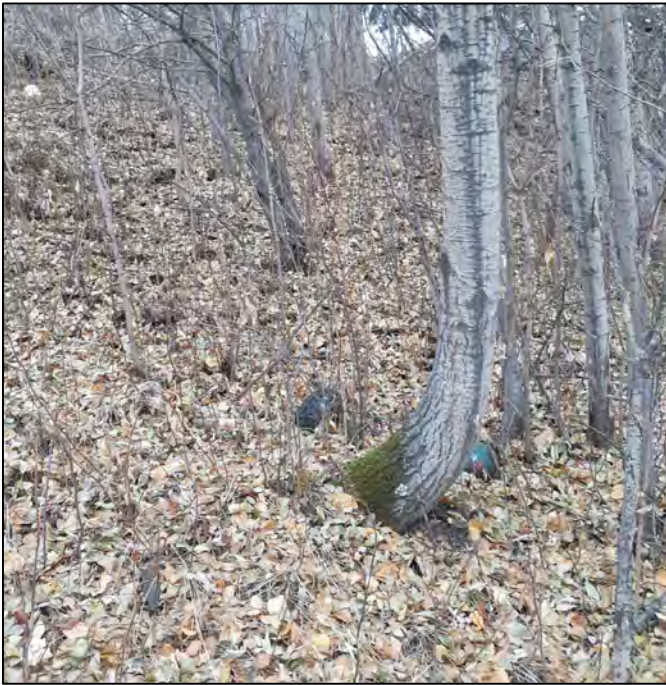
PHOTOGRAPH 74 (2018): 1991 LANDSLIDE SLOPE AND PISTOL-BUTT TREE, FACING EAST
