CLIENT:		SITE PLAN	
			CITY OF RED DEER SLOPE STABILITY EVALUATION EAST RED DEER RIVER BANK (OPPOSITE 3 MILE BEND)	
	DRAWN:	CHK'D:	REV #:	DATE:
	PS	MDB	2	APRIL 2019
SCALE:		JOB NO.		DRAWING NO.
1:7500		RD6500-9/10		FIGURE 9/10-1

**CITY OF RED DEER
SLOPE MONITORING PROGRAM
2018 INSPECTION REPORT**

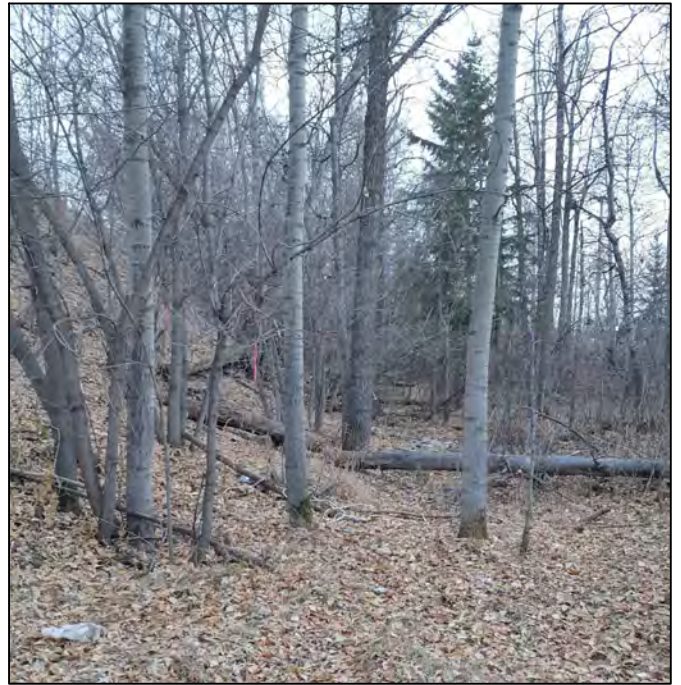
PHOTOGRAPH 78 (2018): TOE OF 1991 LANDSLIDE SLOPE, FACING SOUTHEAST

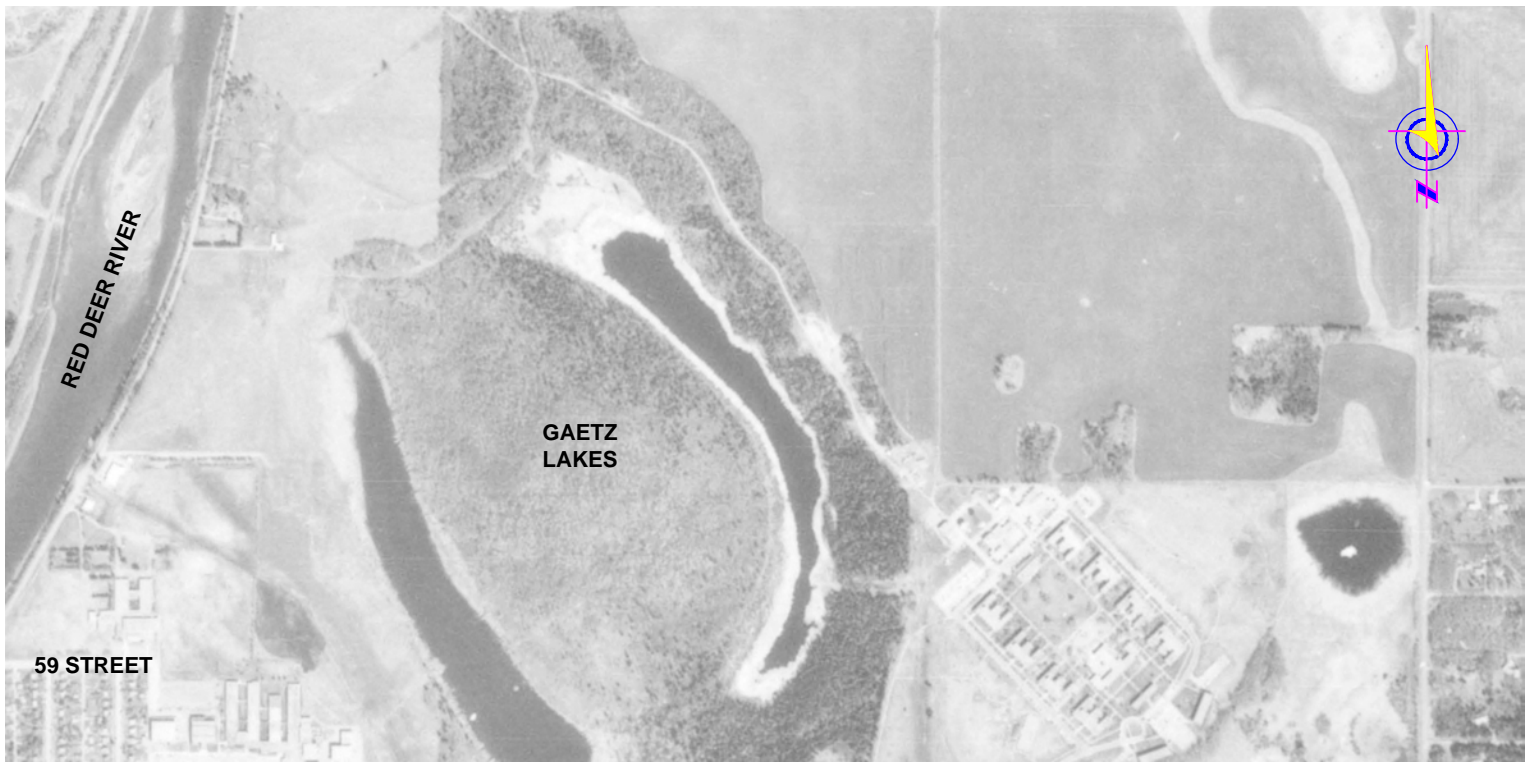
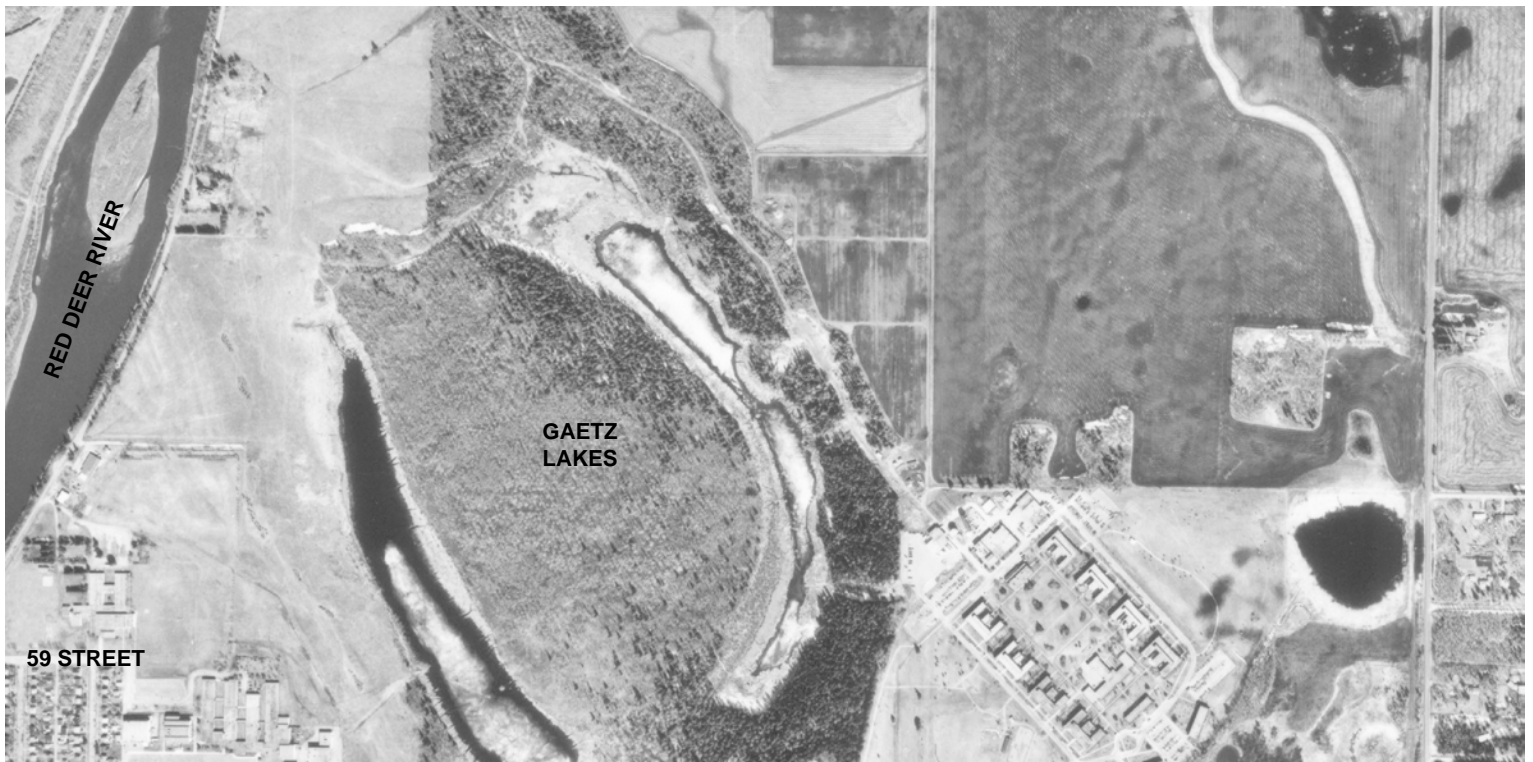
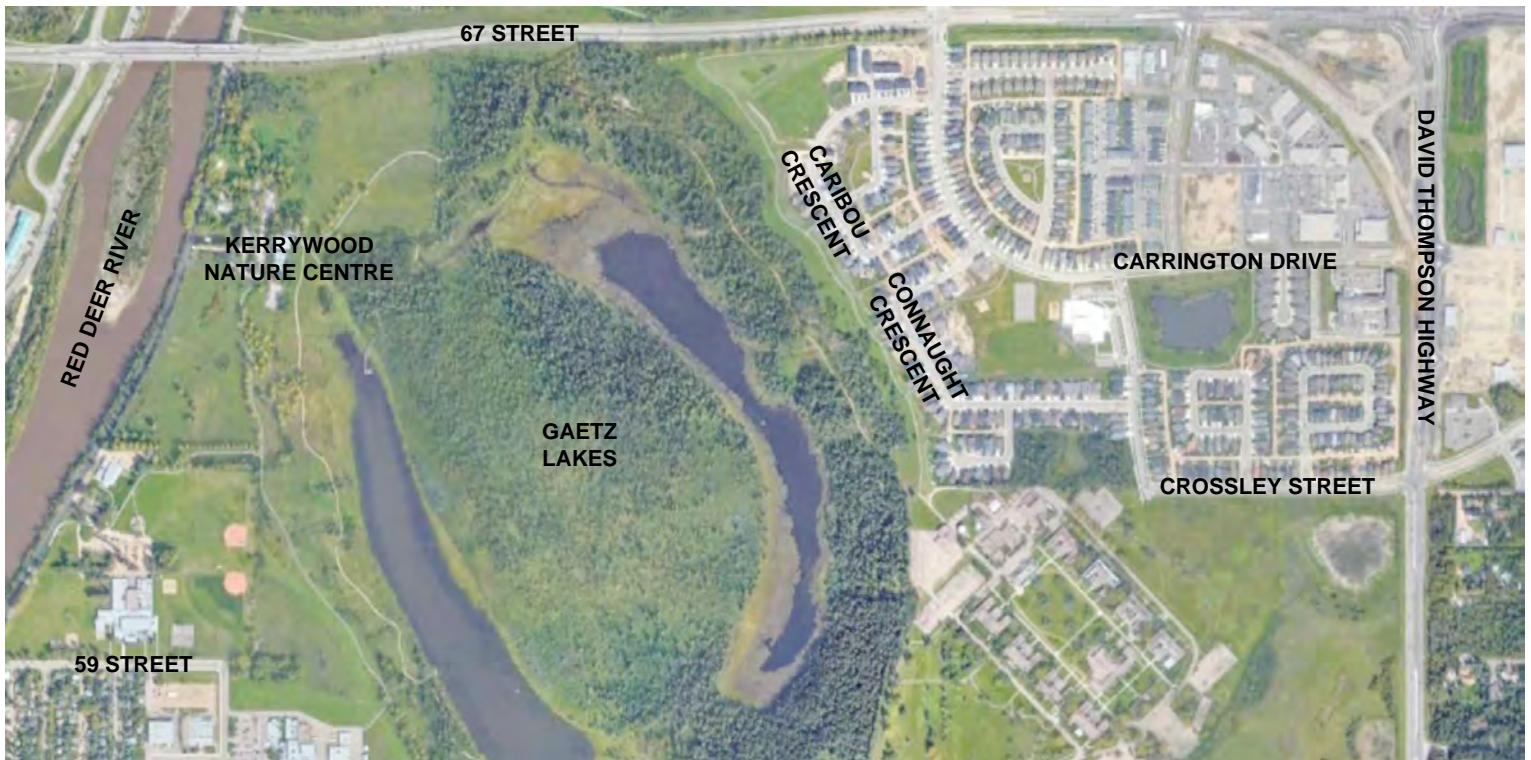
Aerial photography is provided on Figures 27-4A and 27-4B, for the years listed in the following table. The aerials show concur with the anecdotal information suggesting the major landslide occurred in 1981. The small slide site in the south part of the lake was present going back to the at least the 1960s.

Year	Description
1980	Shows the original site condition prior to 1981 landslides
1985	Shows the condition shortly after the 1981 landslides.
2001	Shows the condition of the site about 15 years ago.
2016	Shows the present Site condition.

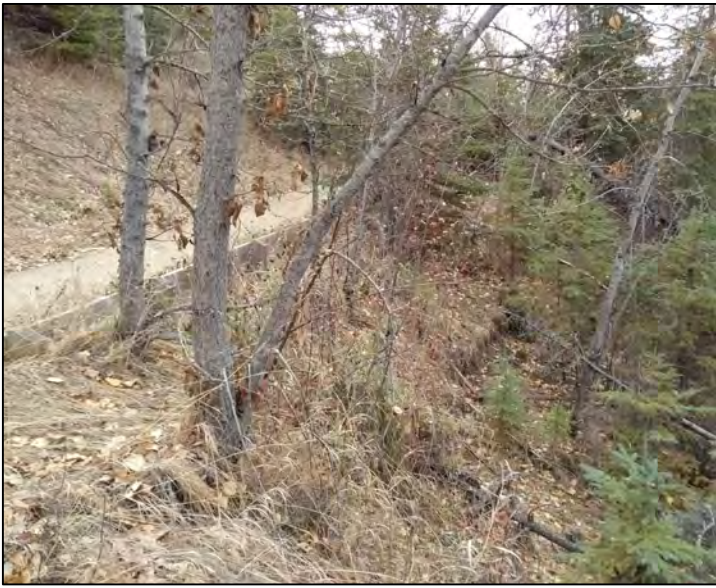
PHOTOGRAPH 55 (2018): SLOPE AT THE MINOR SLIDE, FACING SOUTH

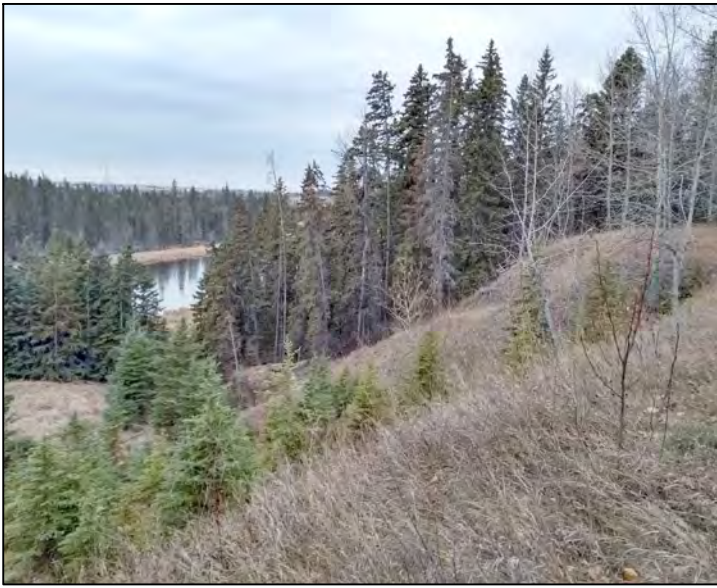
PHOTOGRAPH 58 (2018): CREST OF SLOPE AT THE MINOR SLIDE, FACING EAST

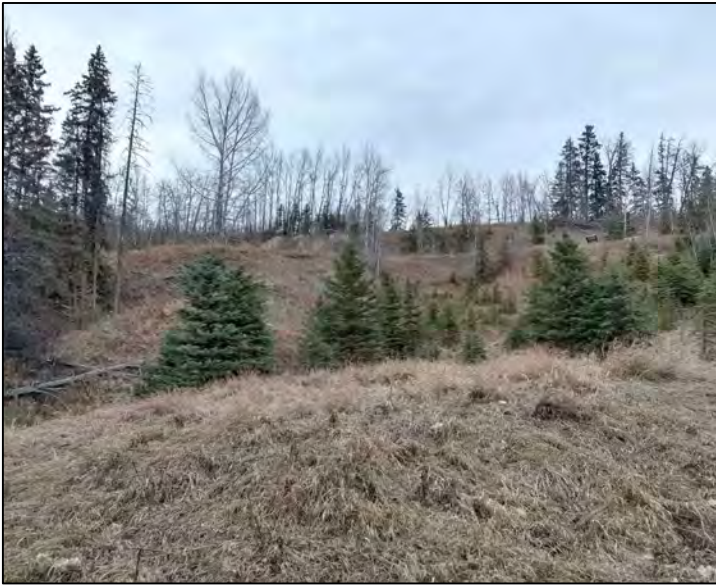
PHOTOGRAPH 62 (2018): MAJOR SLIDE, TAKEN FROM SOUTH OF CREST, FACING WEST
